MARINE POLLUTION SURVEILLANCE REPORT

Analysis Provided by: The National Oceanic and
Atmospheric Administration/National Environmental
Satellite, Data and Information Service (NOAA/NESDIS)

REPORT DATE: June 13, 2011
REPORT TIME: 2215Z (1715 CDT)
ANALYST: Gallina

DATA SOURCE: LANDSAT-5
MODE: MULTISPECTRAL
RESOLUTION: 30 METER
IMAGE DATE/TIME: 6/13/2011 1615Z (1115 CDT)

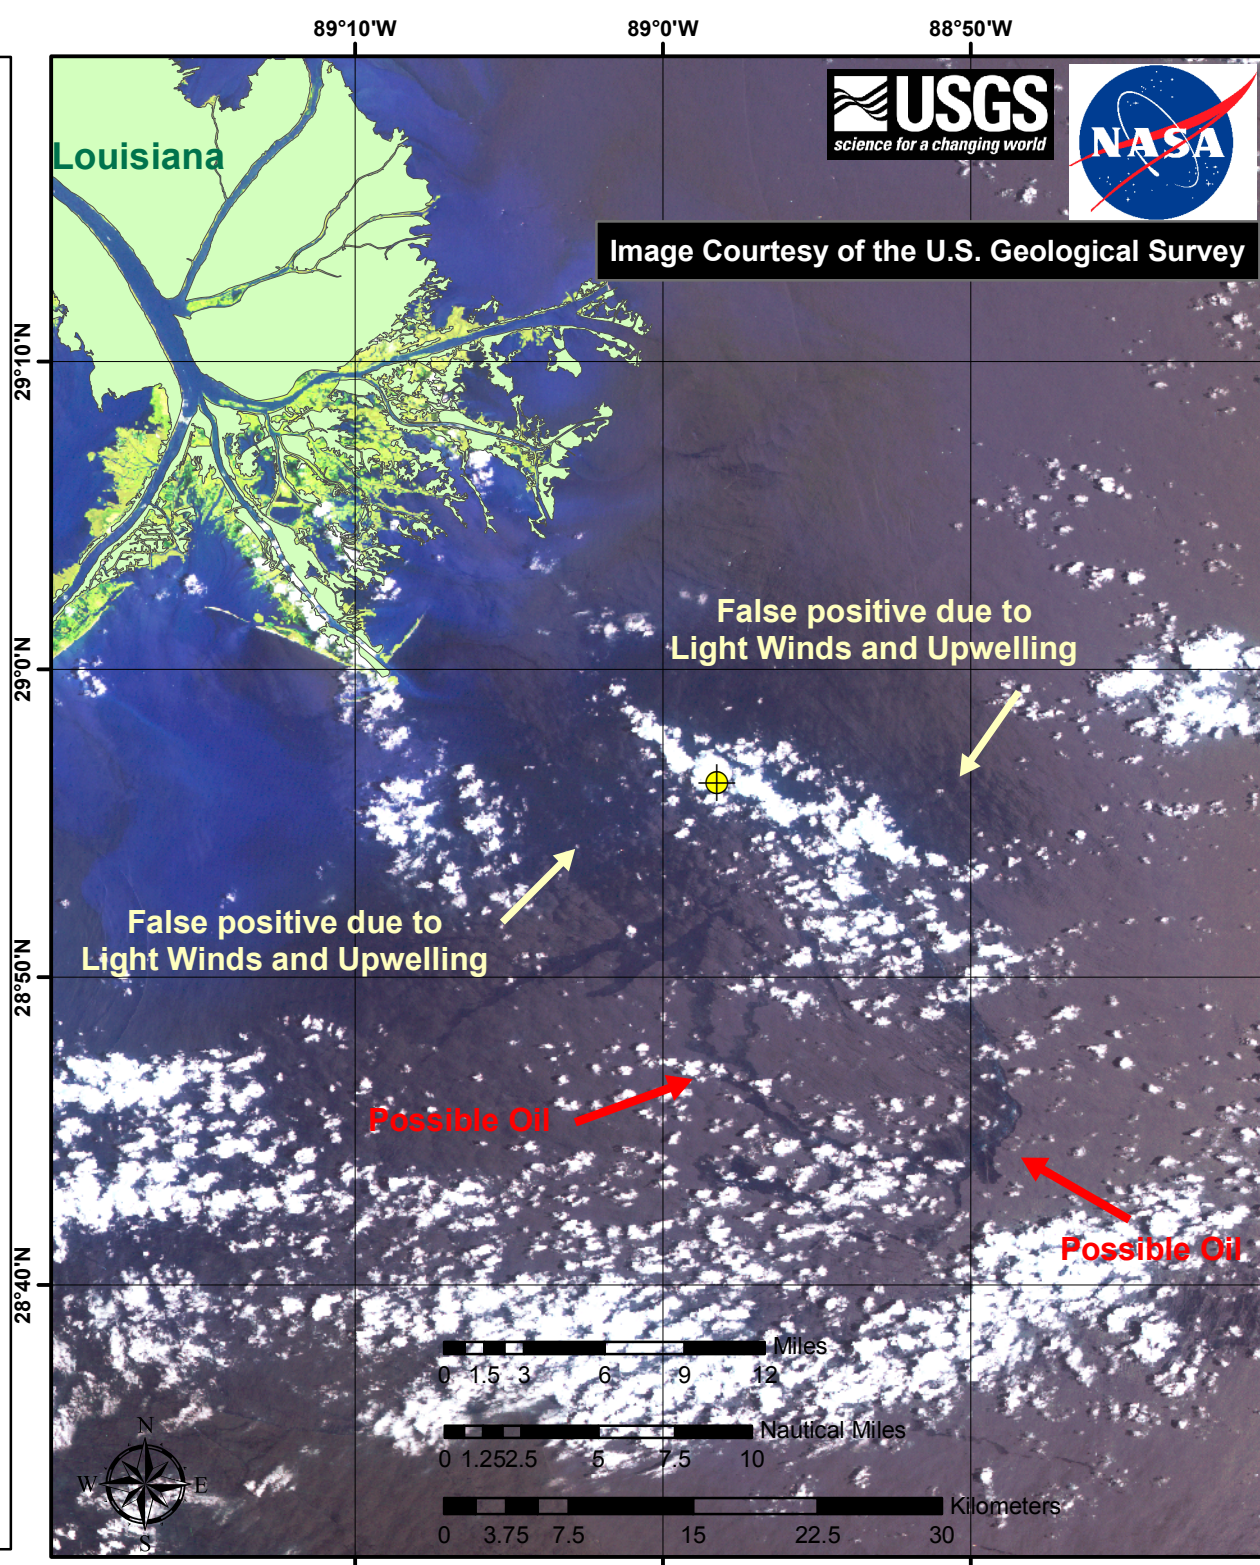
Destroyed Taylor Platform :
[28°56'9" N / 88°58'12" W]

Oil slicks/sheens seen on Landsat-5 imager have a suspected association with the Destroyed Taylor platform. There are multiple ribbons of oil/sheen that have conglomerated into one larger oddly shaped area that covers an area about 19 miles wide (east to west) by 14 miles wide (north to south) and at closest to shore is about 12 miles southeast of the South Pass mouth of the Mississippi River.

There is a large area of cloudiness obscuring the Destroyed Platform site. It is highly plausible that an oil slick could be connecting to this area. Additionally, a large area of low winds and likely upwelling on the northern boundaries of the drawn slicks is leading to a large area of dark false positives.
