MARINE POLLUTION SURVEILLANCE REPORT

Analysis Provided by: The National Oceanic and
Atmospheric Administration/National Environmental
Satellite, Data and Information Service (NOAA/NESDIS)

REPORT DATE: June 22, 2011

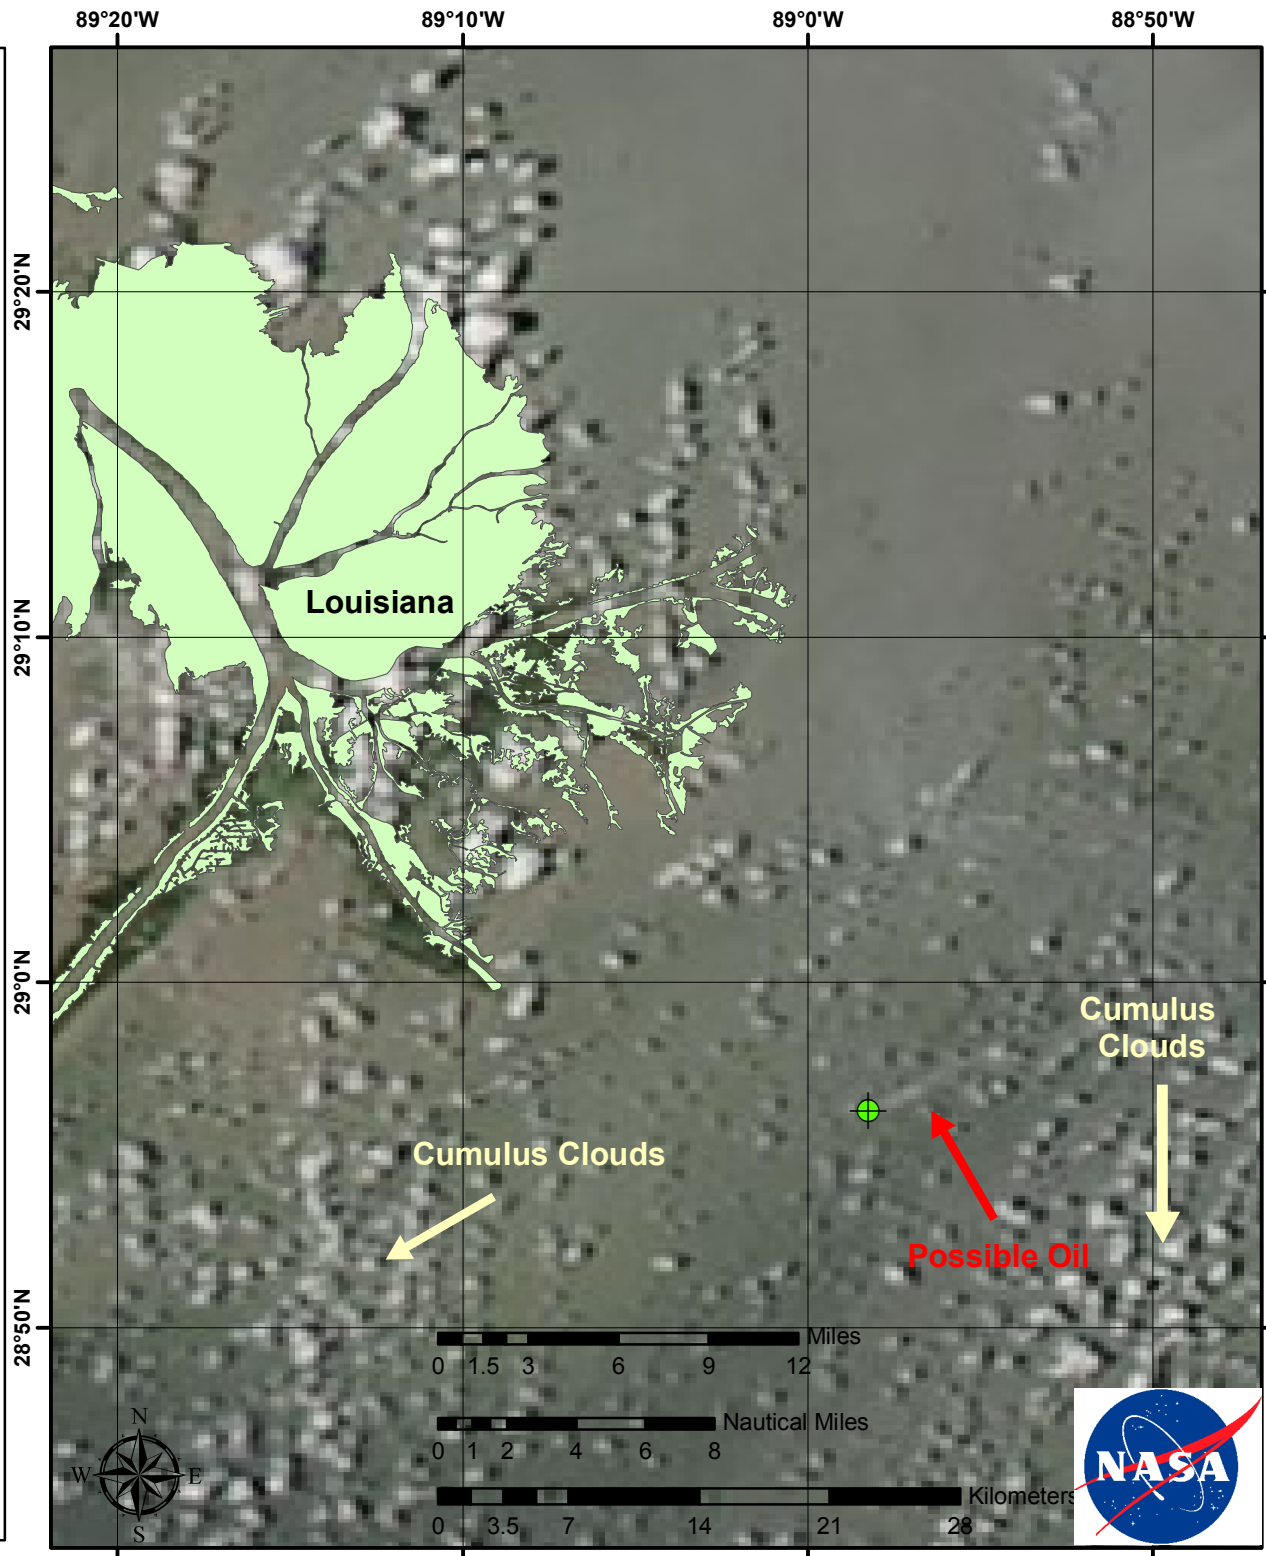
Destroyed Taylor Platform :
[28°56'9" N / 88°58'12" W]

Suspected oil slick seen stretching northeastward from the Destroyed Taylor Platform. Oil slick is just over 6.5 km long and just under 1 km wide. There are many small cumulus clouds in the image but the slick stands out with a more shimmery appearance in the sunglint.
