MARINE POLLUTION SURVEILLANCE REPORT

Analysis Provided by: The National Oceanic and
Atmospheric Administration/National Environmental
Satellite, Data and Information Service (NOAA/NESDIS)

REPORT DATE: June 30, 2011

DATA SOURCE: LANDSAT-5

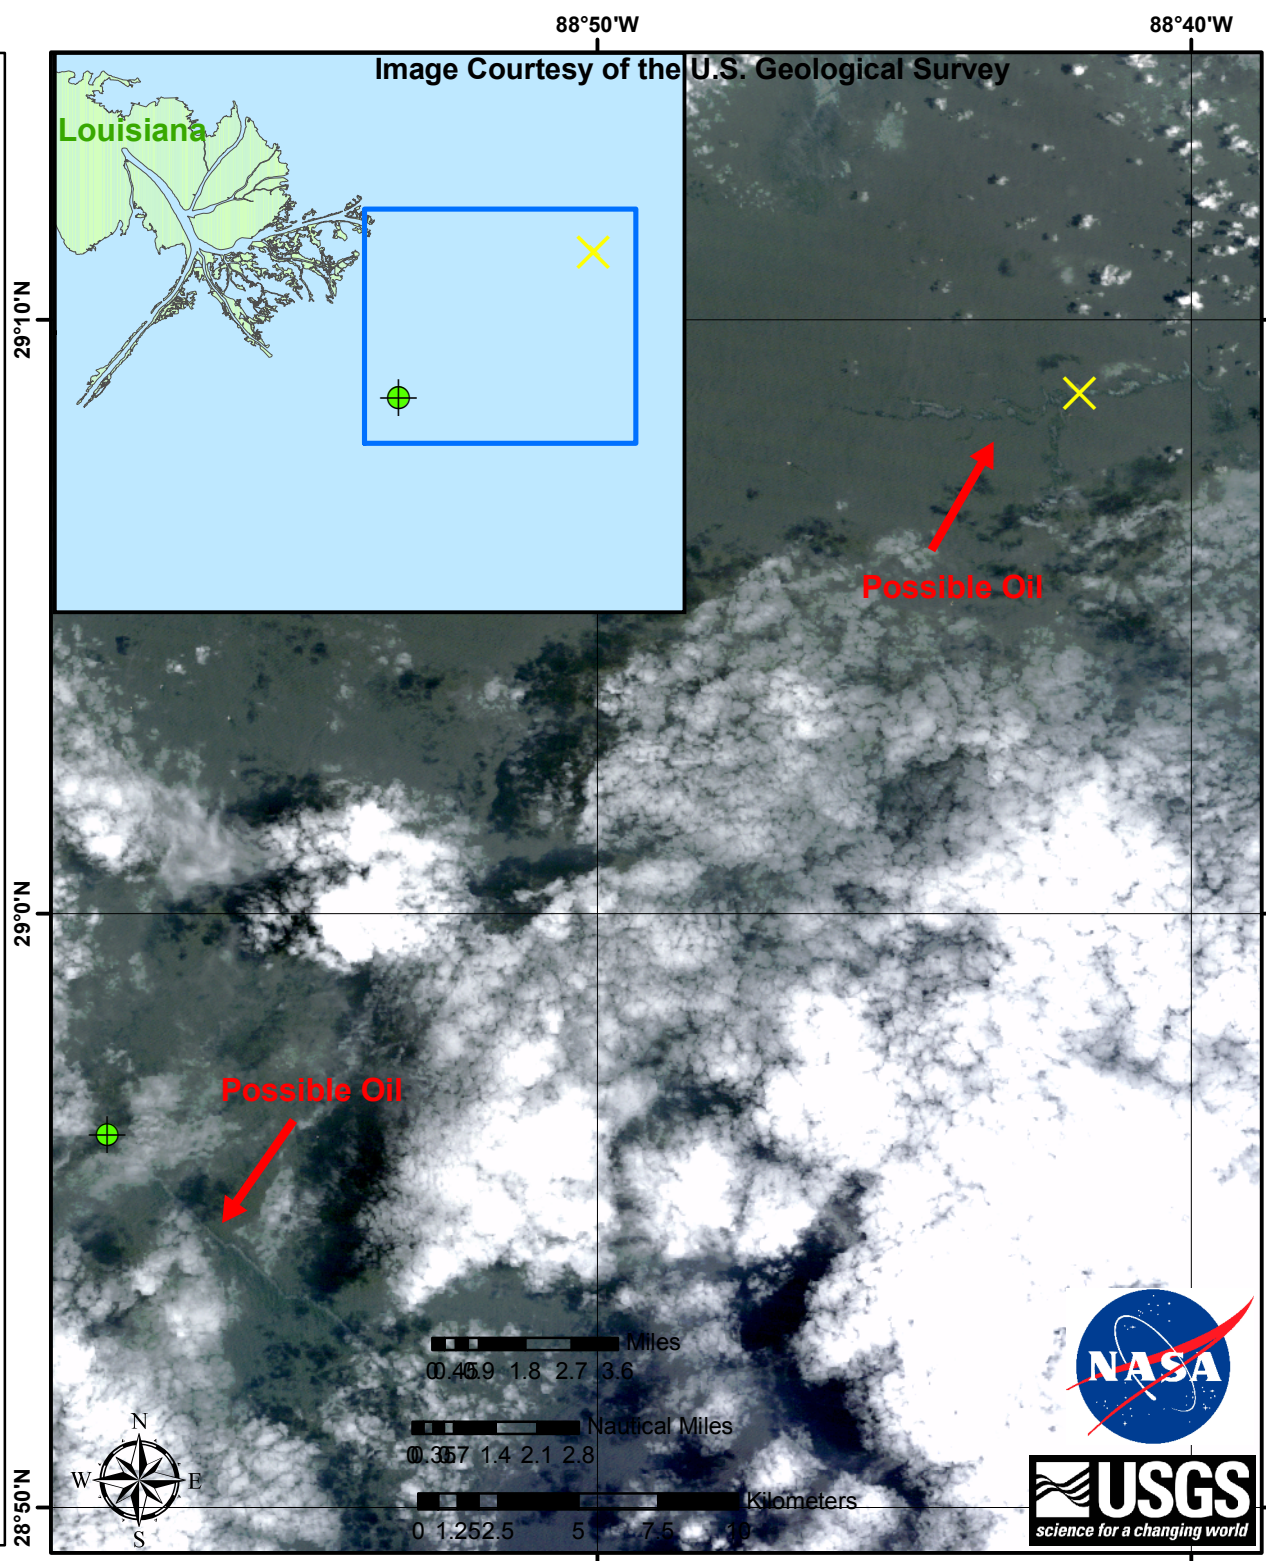
Two possible oil slicks are seen in this Landsat-5 image. One is oriented southeast of the Destroyed Taylor platform and given surface ocean currents at the time, that is believed to be the source point. Clouds may also be obscuring the far northwest part of this slick.

Second area of segmented slicks is seen centered approximately 22 miles northeast of the Destroyed Taylor platform and 25 miles east of the Birds Foot Delta. No source point is apparent with this second area of possible oil.
