# MARINE POLLUTION SURVEILLANCE REPORT

Analysis Provided by: The National Oceanic and  
Atmospheric Administration/National Environmental  
Satellite, Data and Information Service (NOAA/NESDIS)

REPORT DATE: 10/18/2011  
REPORT TIME: 1900Z (1400 CDT)  
ANALYST: LIDDICK

DATA SOURCE: MODIS TERRA  
MODE: MULTI-SPECTRAL  
RESOLUTION: 250 m  
IMAGE DATE/TIME: 10/18/2011 1645Z (1145 CDT)

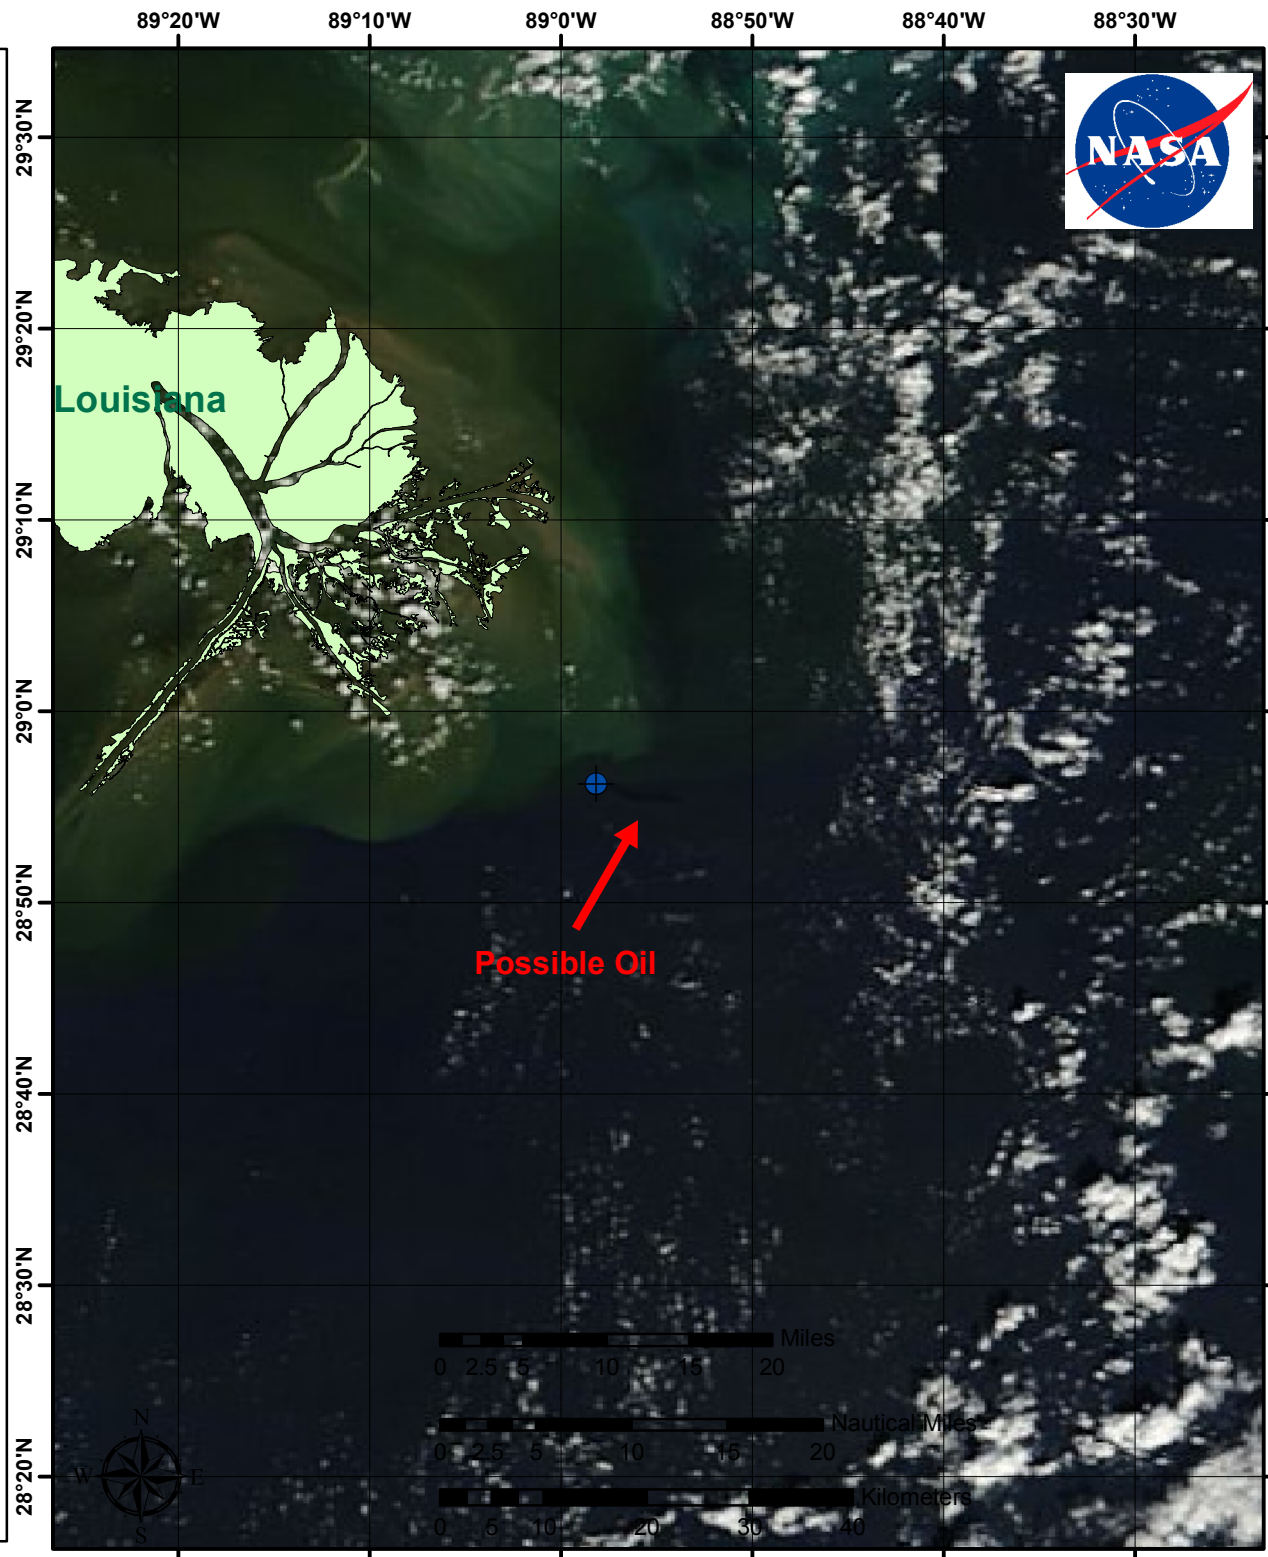
Destroyed Taylor Platform :  
[ 28°56'9" N / 88°58'12" W ]

POSSIBLE OIL PLUME ABOUT .25 TO .75 MILES  
WIDE SEEN EXTENDING 4 MILES ESE OF THE  
TAYLOR PLATFORM. PLUME STILL APPEARS TO BE  
ATTACHED TO THE PLATFORM.
