MARINE POLLUTION SURVEILLANCE REPORT

REPORT DATE: May 4, 2011
REPORT TIME: 2245Z (1745 CDT)
ANALYST: VOGT

DATA SOURCE: LANDSAT7
MODE: MULTISPECTRAL
RESOLUTION: 30 METER
IMAGE DATE/TIME: 05/04/11 1619Z (05/04/11 1119 CDT)

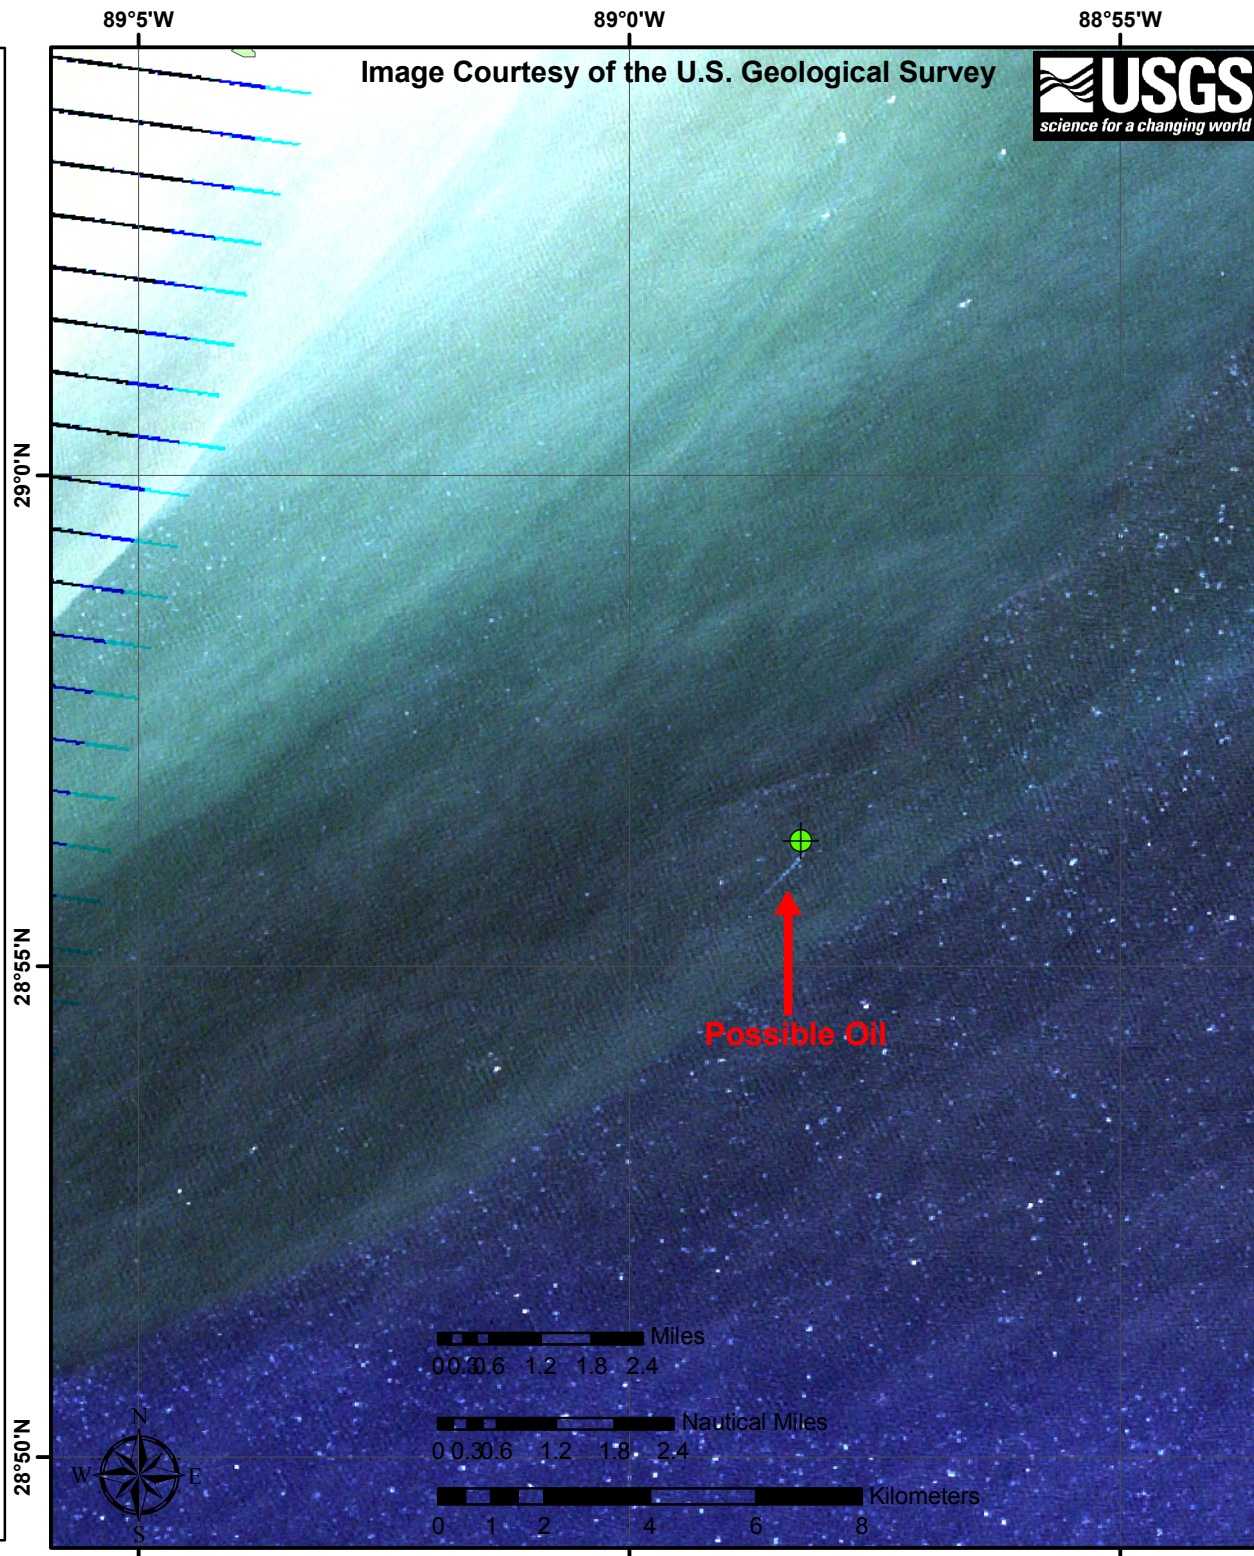
Destroyed Taylor Platform :
[28°56'9" N / 88°58'12" W]

REMARKS: Possible oil slick originating from the
destroyed Taylor Platform and extends about 1 mile to
the Southwest.
