MARINE POLLUTION SURVEILLANCE REPORT

Analysis Provided by: The National Oceanic and
Atmospheric Administration/National Environmental
Satellite, Data and Information Service (NOAA/NESDIS)

REPORT DATE: SEP 22, 2011
REPORT TIME: 1900Z (1400 CDT)
ANALYST: LIDDICK

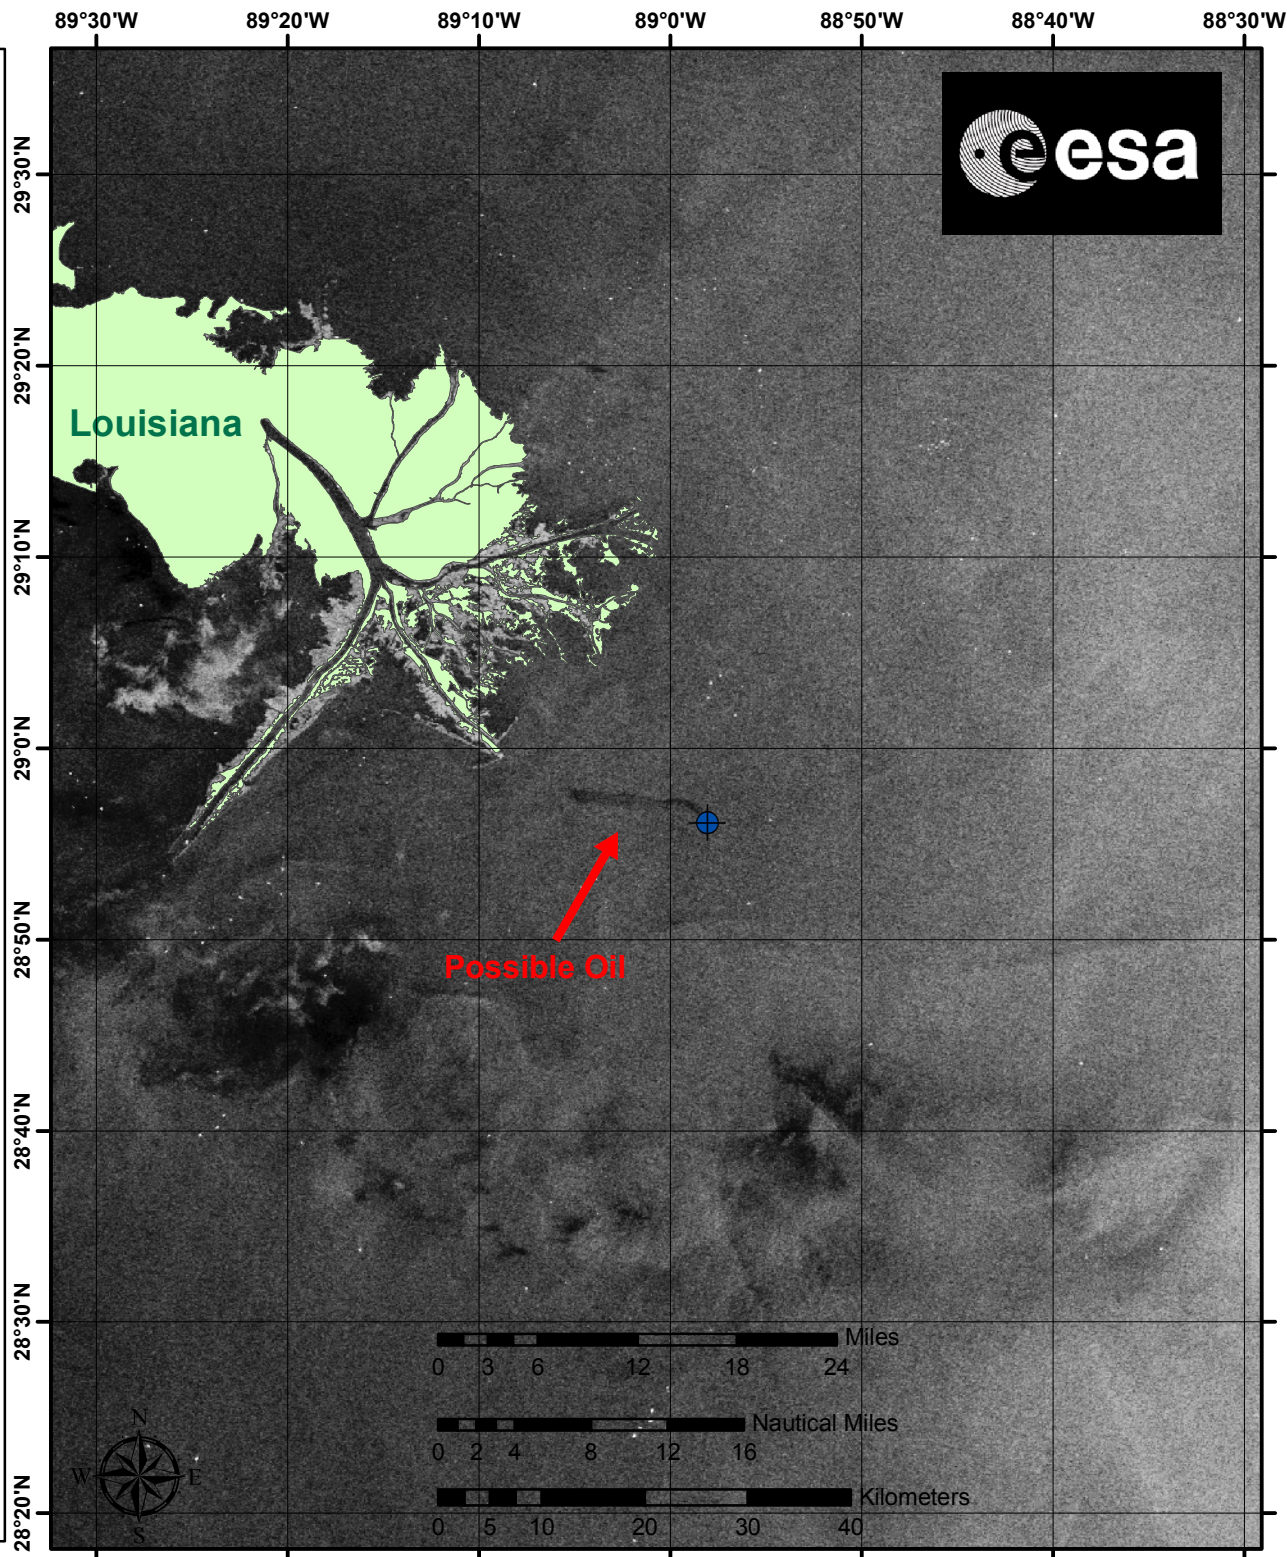
Destroyed Taylor Platform :
[28°56'9" N / 88°58'12" W]

POSSIBLE OIL SEEN EXTENDING ABOUT 7.5 MILES
TO THE WEST OF THE DESTROYED TAYLOR
PLATFORM. THE SLICK IS APPROXIMATELY .75
MILES WIDE AT ITS THICKEST.
