# MARINE POLLUTION SURVEILLANCE REPORT

REPORT DATE: May 28, 2011  
REPORT TIME: 2245Z (1745 CDT)  
ANALYST: SHEFFLER

DATA SOURCE: LandSat-5  
MODE: TM MULTI-SPECTRAL  
RESOLUTION: 30 METERS  
IMAGE DATE/TIME: 5/28/2011 1615Z (5/28/11 1115 CDT)

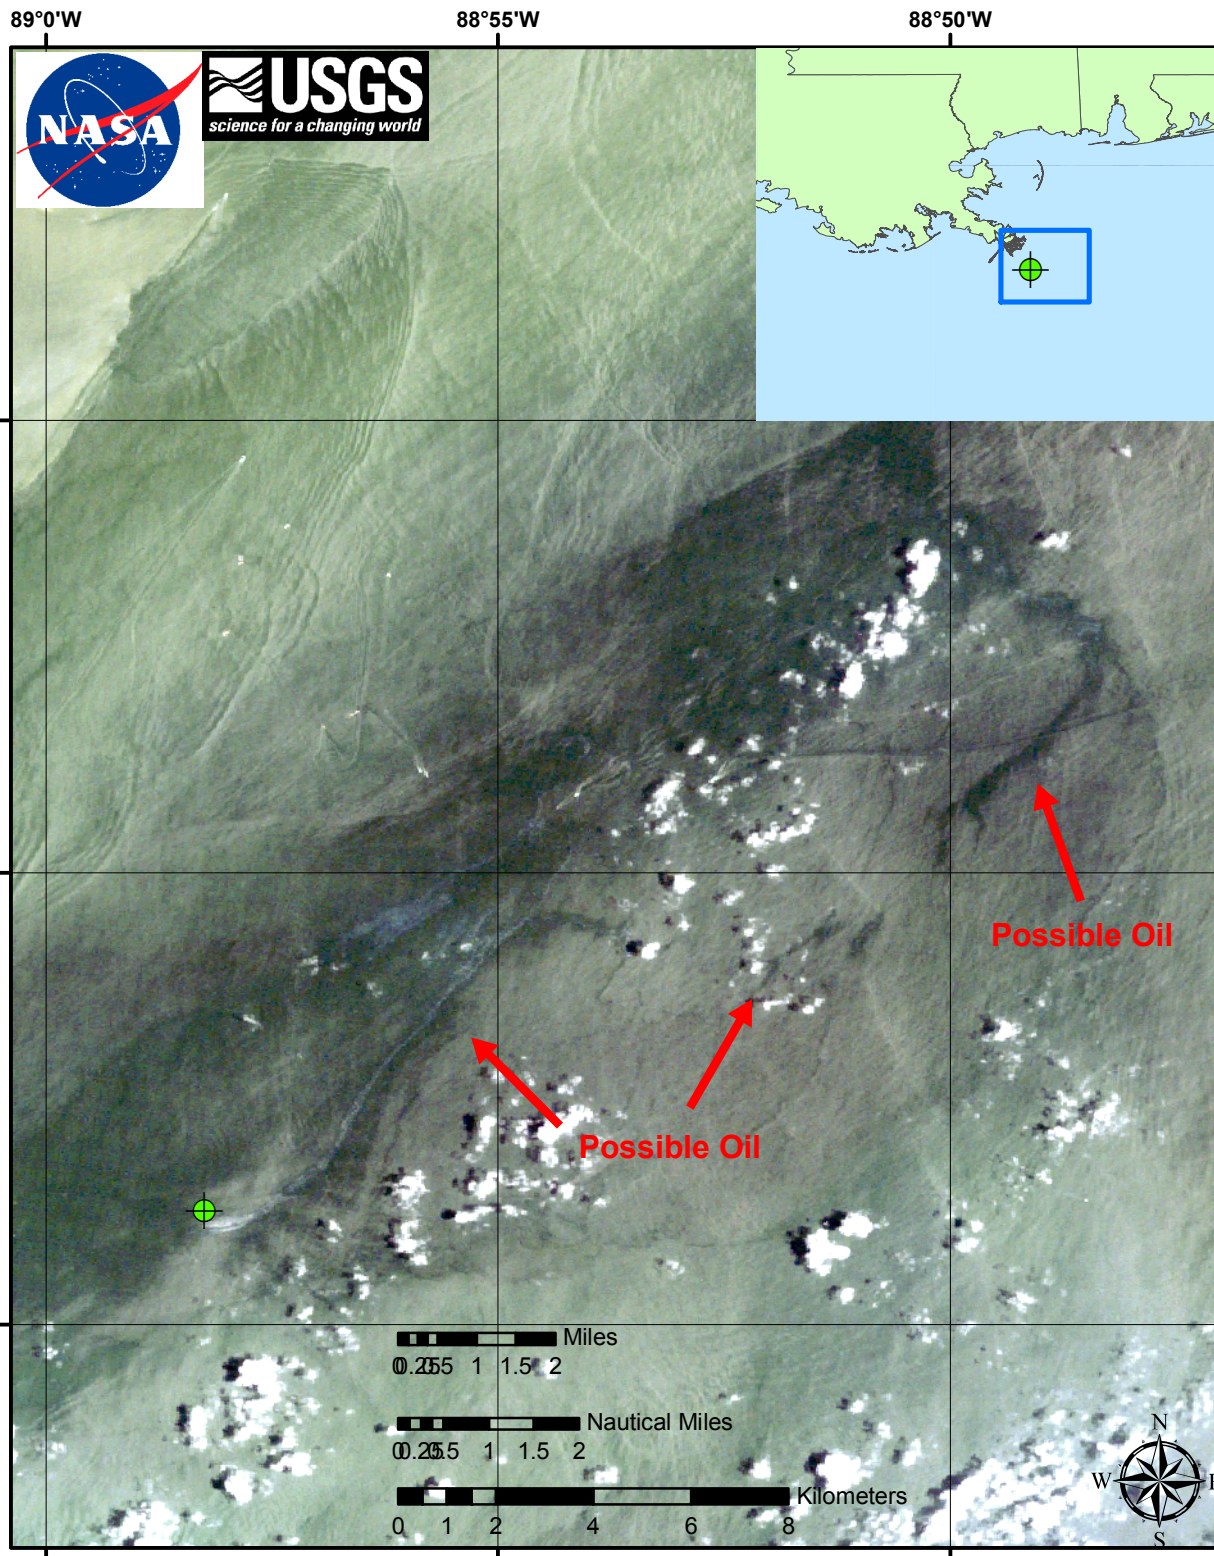
Destroyed Taylor Platform :  
[ 28°56'9" N / 88°58'12" W ]

Suspected oil is seen originating from the Destroyed Taylor platform in this Landsat-5 image. NCOM model data indicates the presence of a convergence zone off the southeast corner of the Birds' Foot Delta with west to west-southwest surface currents. For this reason, all of the suspected oil seen in this image is believed to be from the Destroyed Taylor.
