MARINE POLLUTION SURVEILLANCE REPORT

Analysis Provided by: The National Oceanic and
Atmospheric Administration/National Environmental
Satellite, Data and Information Service (NOAA/NESDIS)

REPORT DATE: July 13, 2011

Destroyed Taylor Platform :
[28°56'9" N / 88°58'12" W]

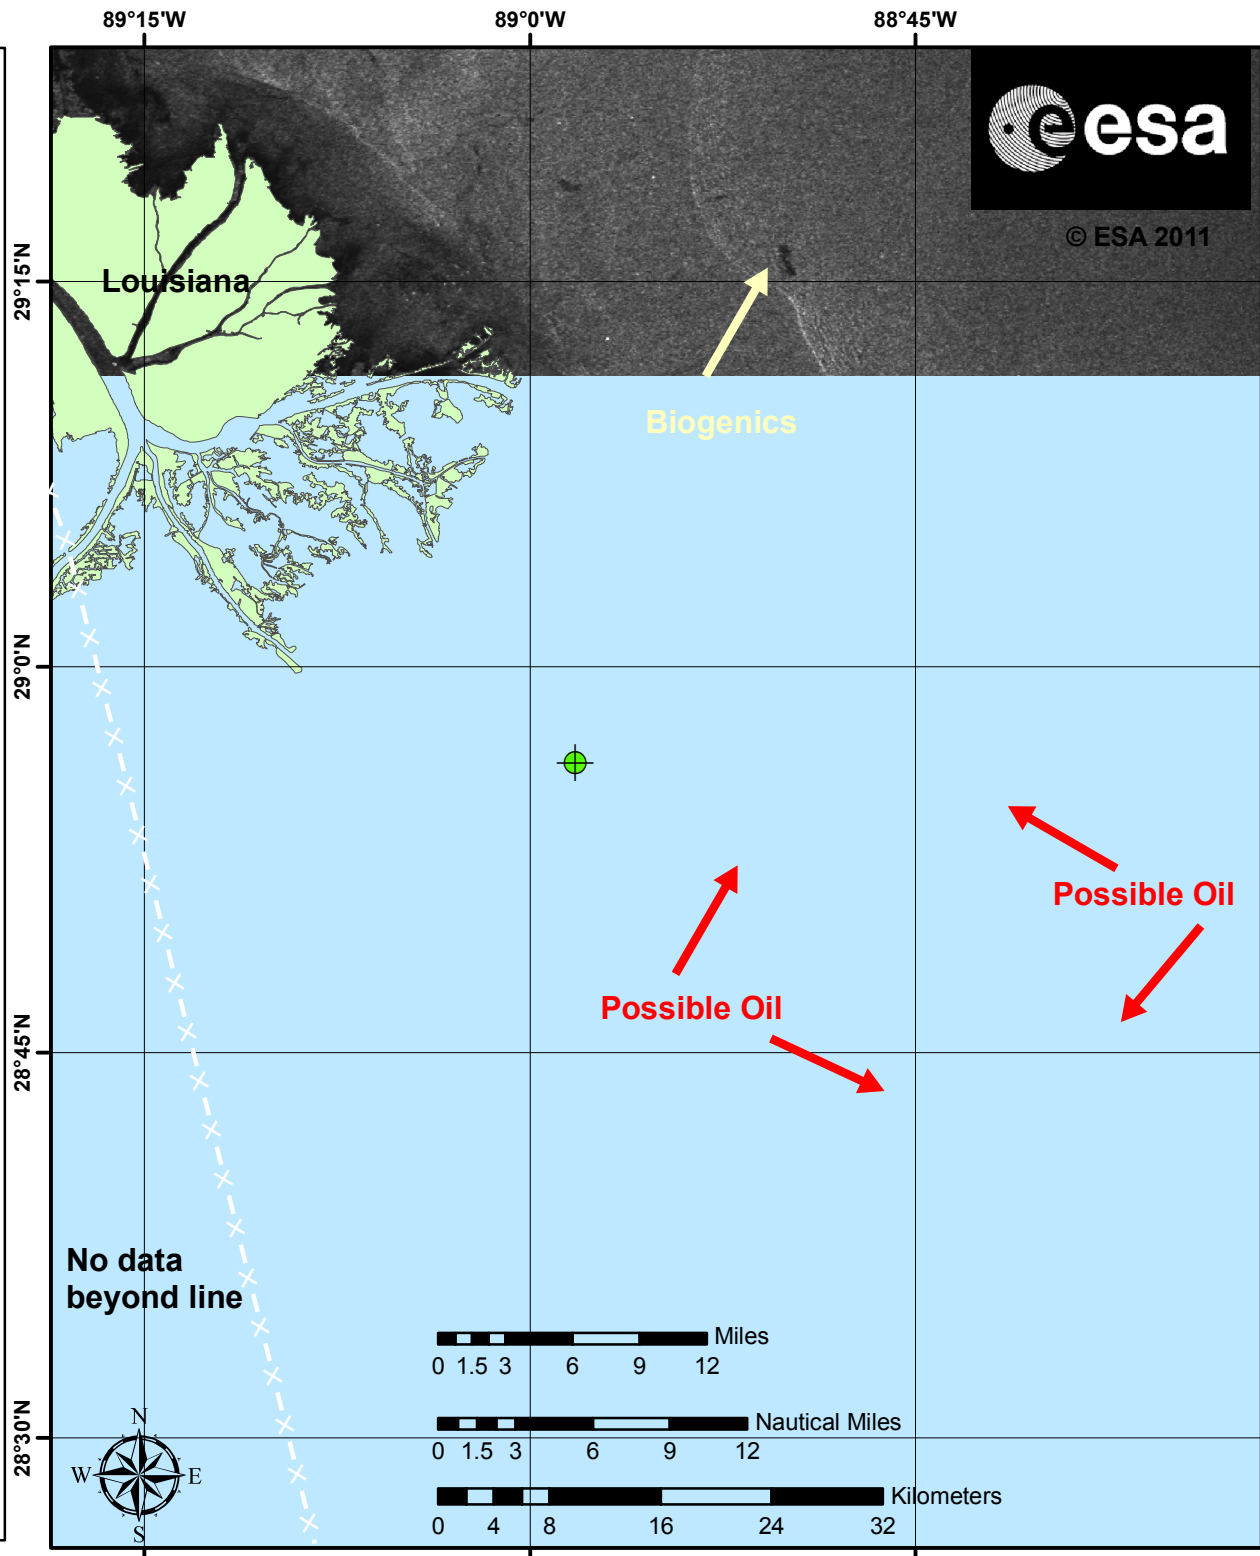
Large oil slick seen in image originating from the Destroyed Taylor Platform. This slick extends almost 40 km southeast from the Taylor then wraps around to the north and extends another 17 km. The slick appears widest closest to the platform and then thins out as it wraps back to the north. This slick had a very high contrast compared to its surroundings. The only other dark features in the image are very small and are likely biogenic features.
