# MARINE POLLUTION SURVEILLANCE REPORT

REPORT DATE: June 12, 2011  
REPORT TIME: 2200Z (1700 CDT)  
ANALYST: WARREN

Destroyed Taylor Platform :  
[ 28°56'9" N / 88°58'12" W ]

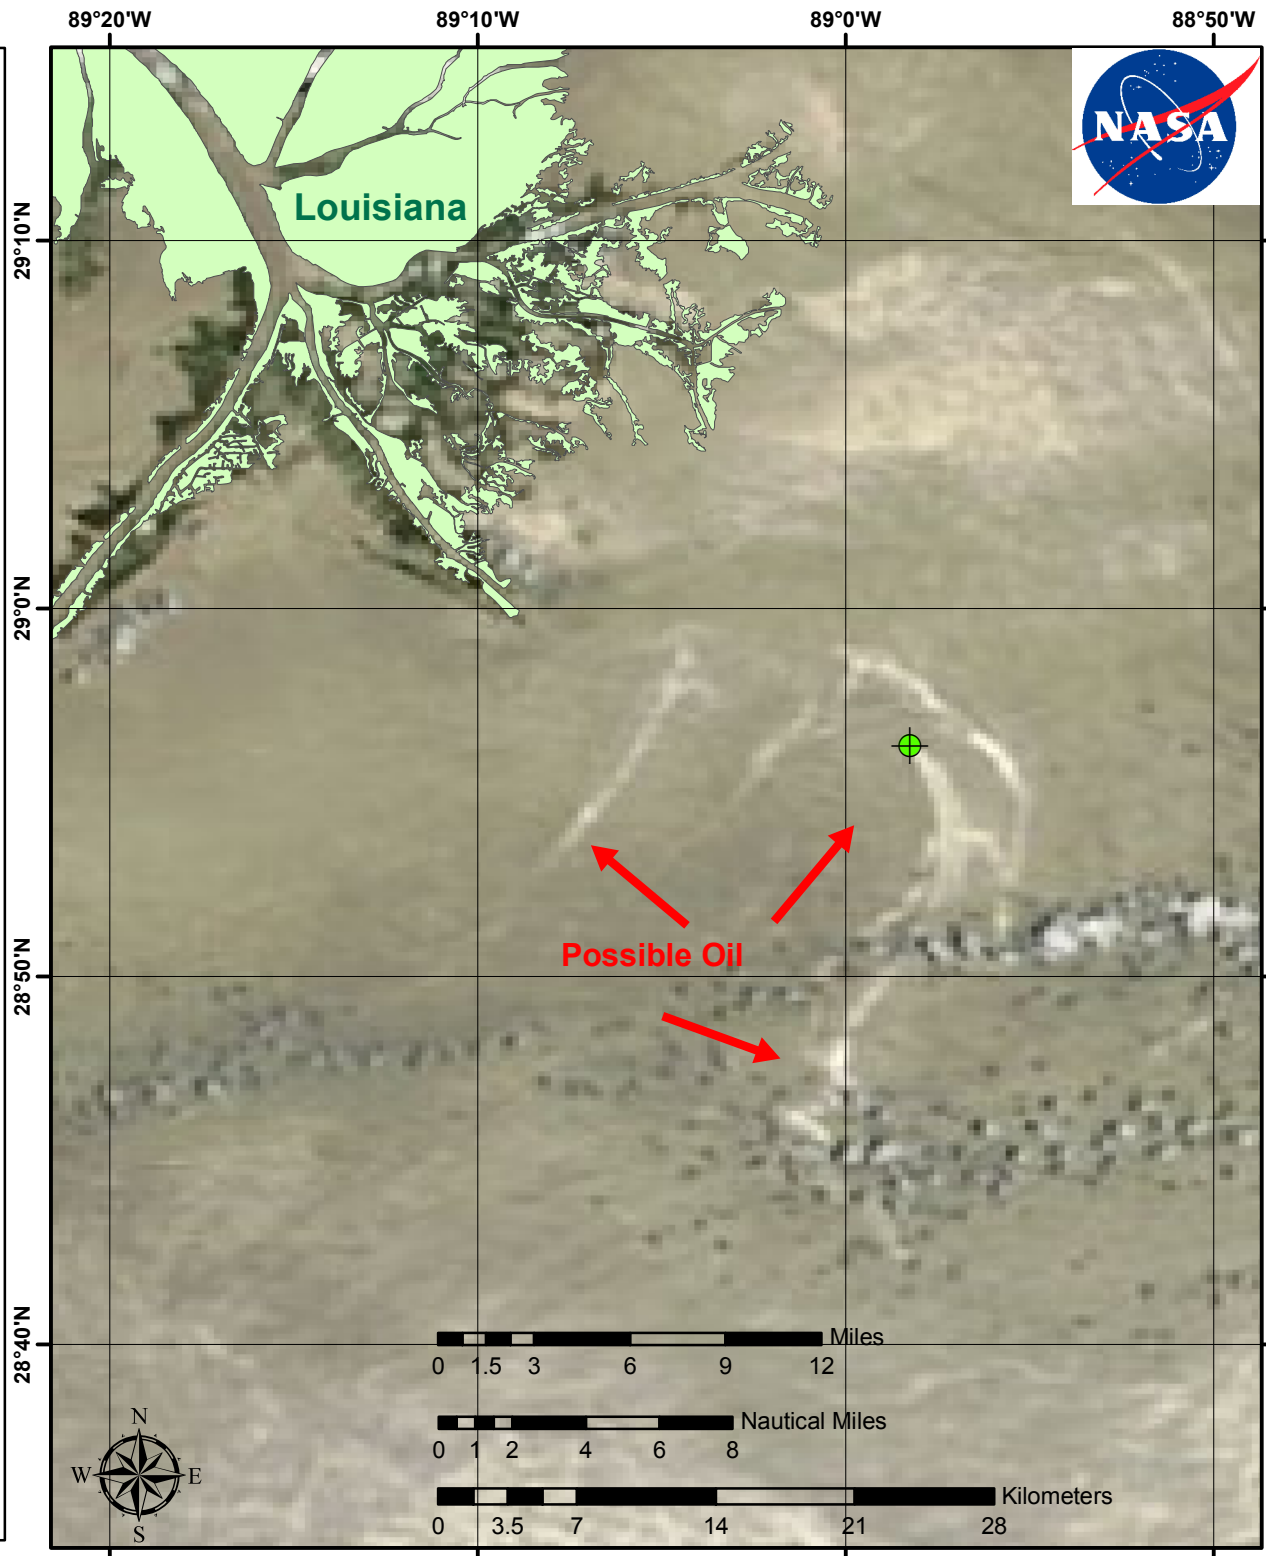
Oil slicks/sheens captured in this late-morning satellite image are suspected to be associated with the Destroyed Talyor. There are three separated slicks/sheens, with the large one still connected to the suspected point source.

Oil is suspected to be now getting pulled to the south-southwest based on surface ocean currents. Additionally, history of ocean currents from past 12-18 hrs indicated an eddy in the region and then throughout the day, eddy broke down and turn more unidirectional from south-east to now south-west. Thus helping to explain why the two detached oil slicks are seen to the west of the source.
