MARINE POLLUTION SURVEILLANCE REPORT

Analysis Provided by: The National Oceanic and
Atmospheric Administration/National Environmental
Satellite, Data and Information Service (NOAA/NESDIS)

REPORT DATE: July 31, 2011
REPORT TIME: 2110Z (1710 CDT)
ANALYST: WARREN

DATA SOURCE: LANDSAT-5
MODE: MULTISPECTRAL
RESOLUTION: 30 METERS
IMAGE DATE/TIME: 7/31/2011 1615Z (1115 CDT)

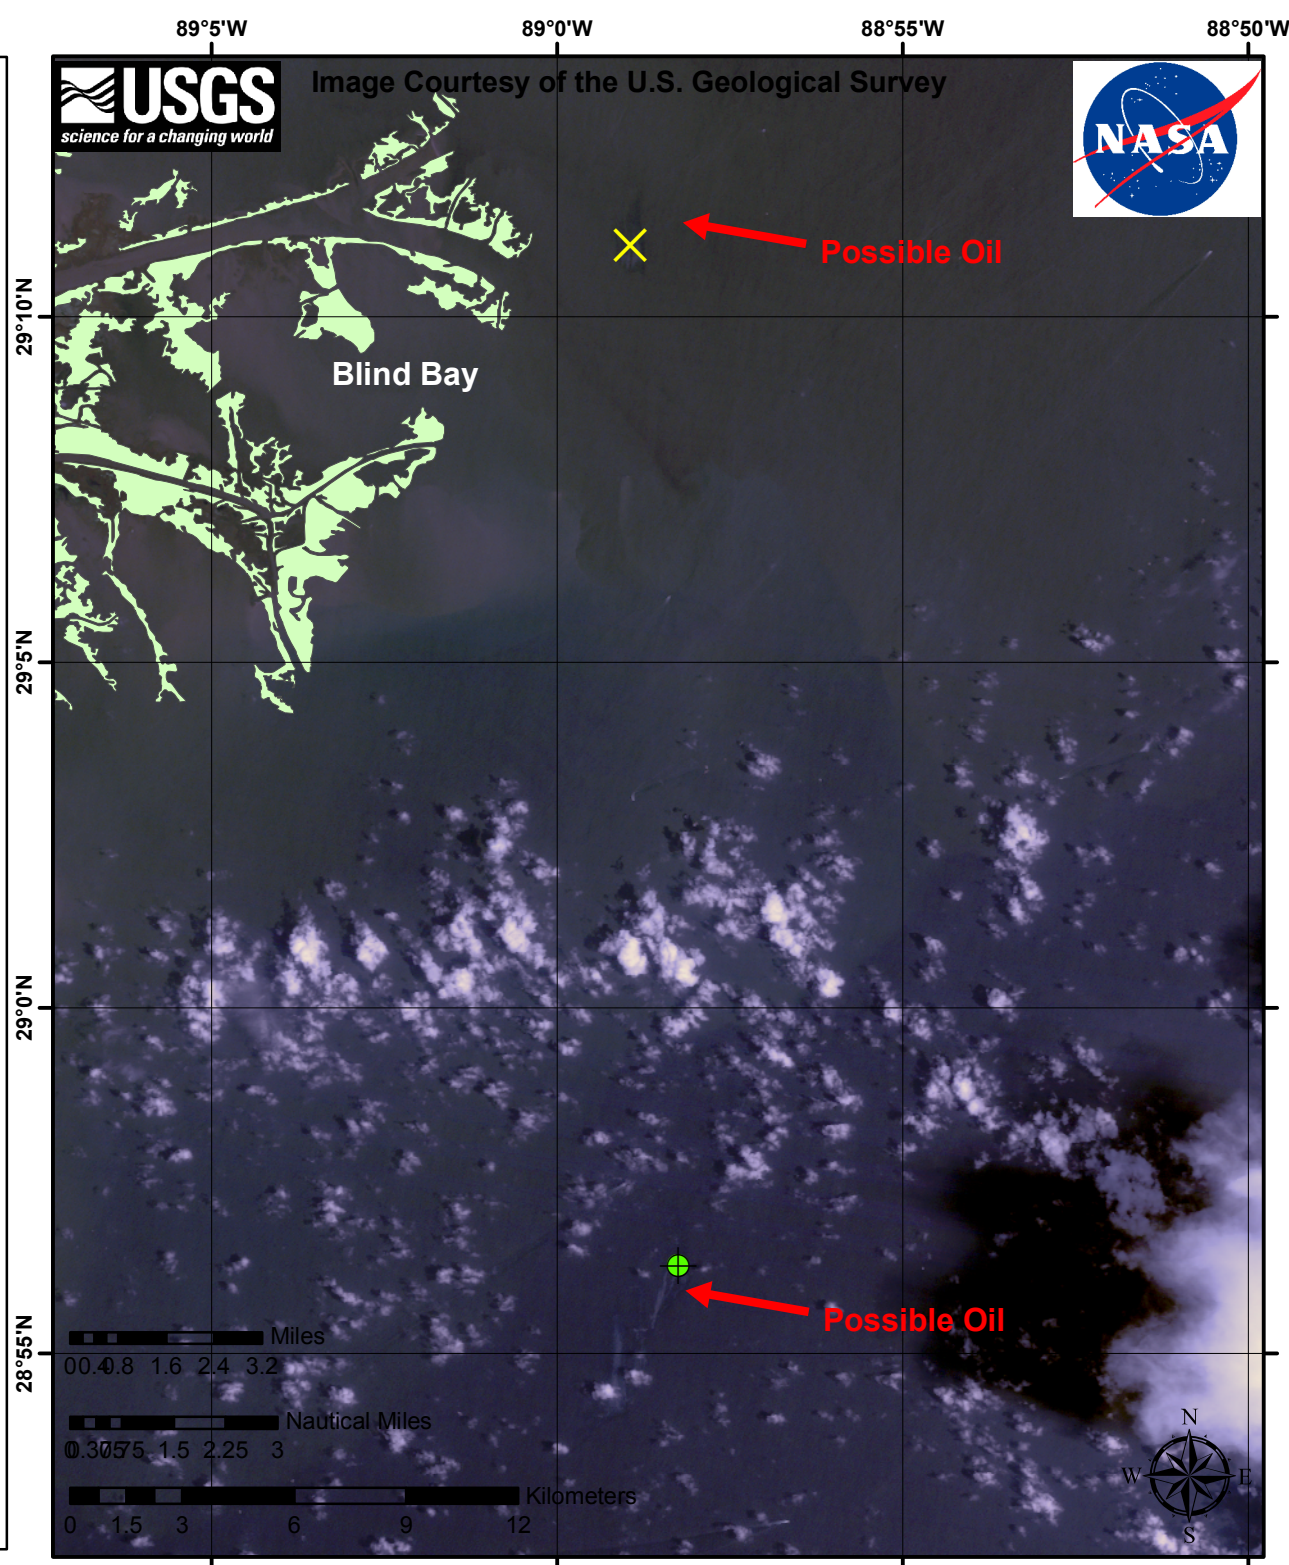
Suspected oil slick believed to be originating from
Destroyed Taylor platform is seen extending 2.8 miles to
the southwest. It is approximately 0.5 miles wide.

A suspected oil sheen is seen 17 miles due north of
Destroyed Taylor. It is about 3 miles east-northeast of
Blind Bay, LA and 1.2 miles long by 0.4 miles wide. No
discernable point source can be identified with this
sheen.
