MARINE POLLUTION SURVEILLANCE REPORT

Analysis Provided by: The National Oceanic and
Atmospheric Administration/National Environmental
Satellite, Data and Information Service (NOAA/NESDIS)

REPORT DATE: MAY 23, 2012
REPORT TIME: 2140Z (1640 CDT)
ANALYST: TURK

DATA SOURCE: AQUA MODIS
MODE: MULTI-SPECTRAL
RESOLUTION: 250 METER
IMAGE DATE/TIME: 5/23/2012 1900Z (1400 CDT)

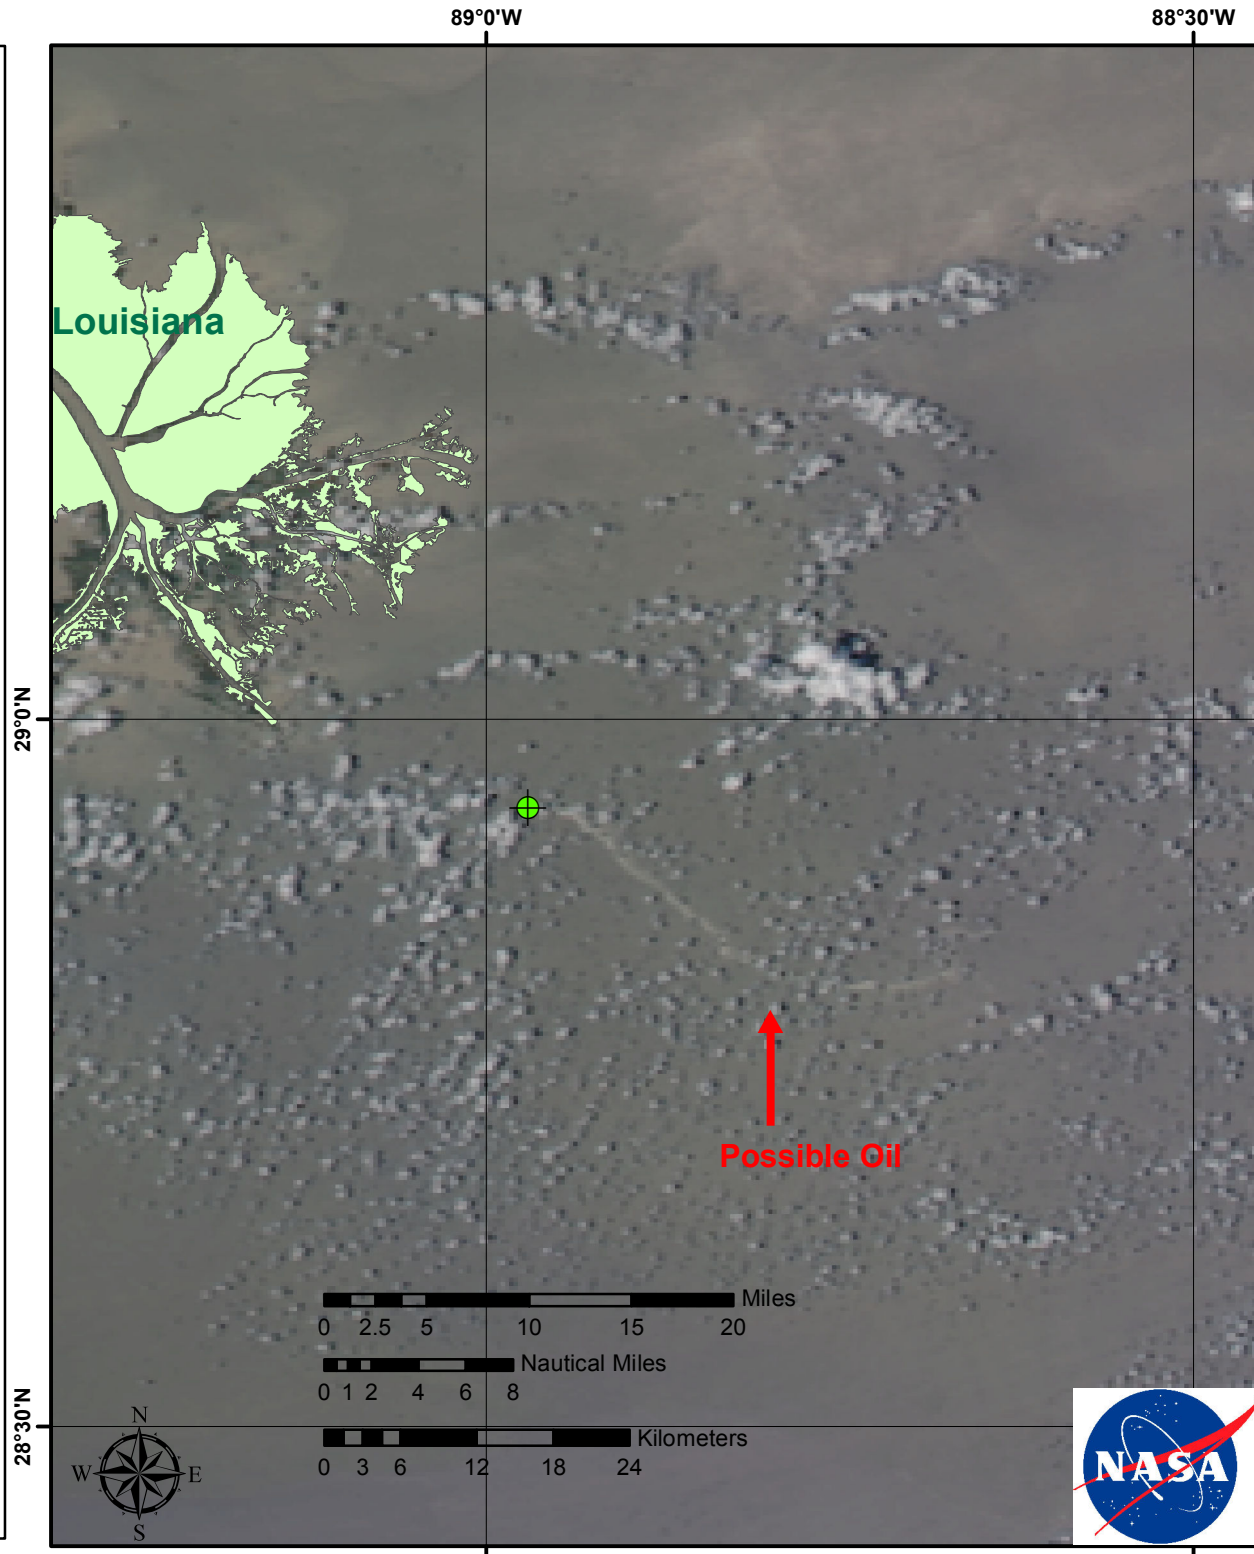
Destroyed Taylor Platform :
[28°56'9" N / 88°58'12" W]

A suspected oil slick extended 21.1 miles to the east-southeast of the destroyed Taylor platform. Winds were from the west at 5-10 knots and skies were partly cloudy at the time of the image.
