MARINE POLLUTION SURVEILLANCE REPORT

Analysis Provided by: The National Oceanic and
Atmospheric Administration/National Environmental
Satellite, Data and Information Service (NOAA/NESDIS)

REPORT DATE: MAY 04, 2012
REPORT TIME: 2100Z (1600 CDT)
ANALYST: RAMIREZ

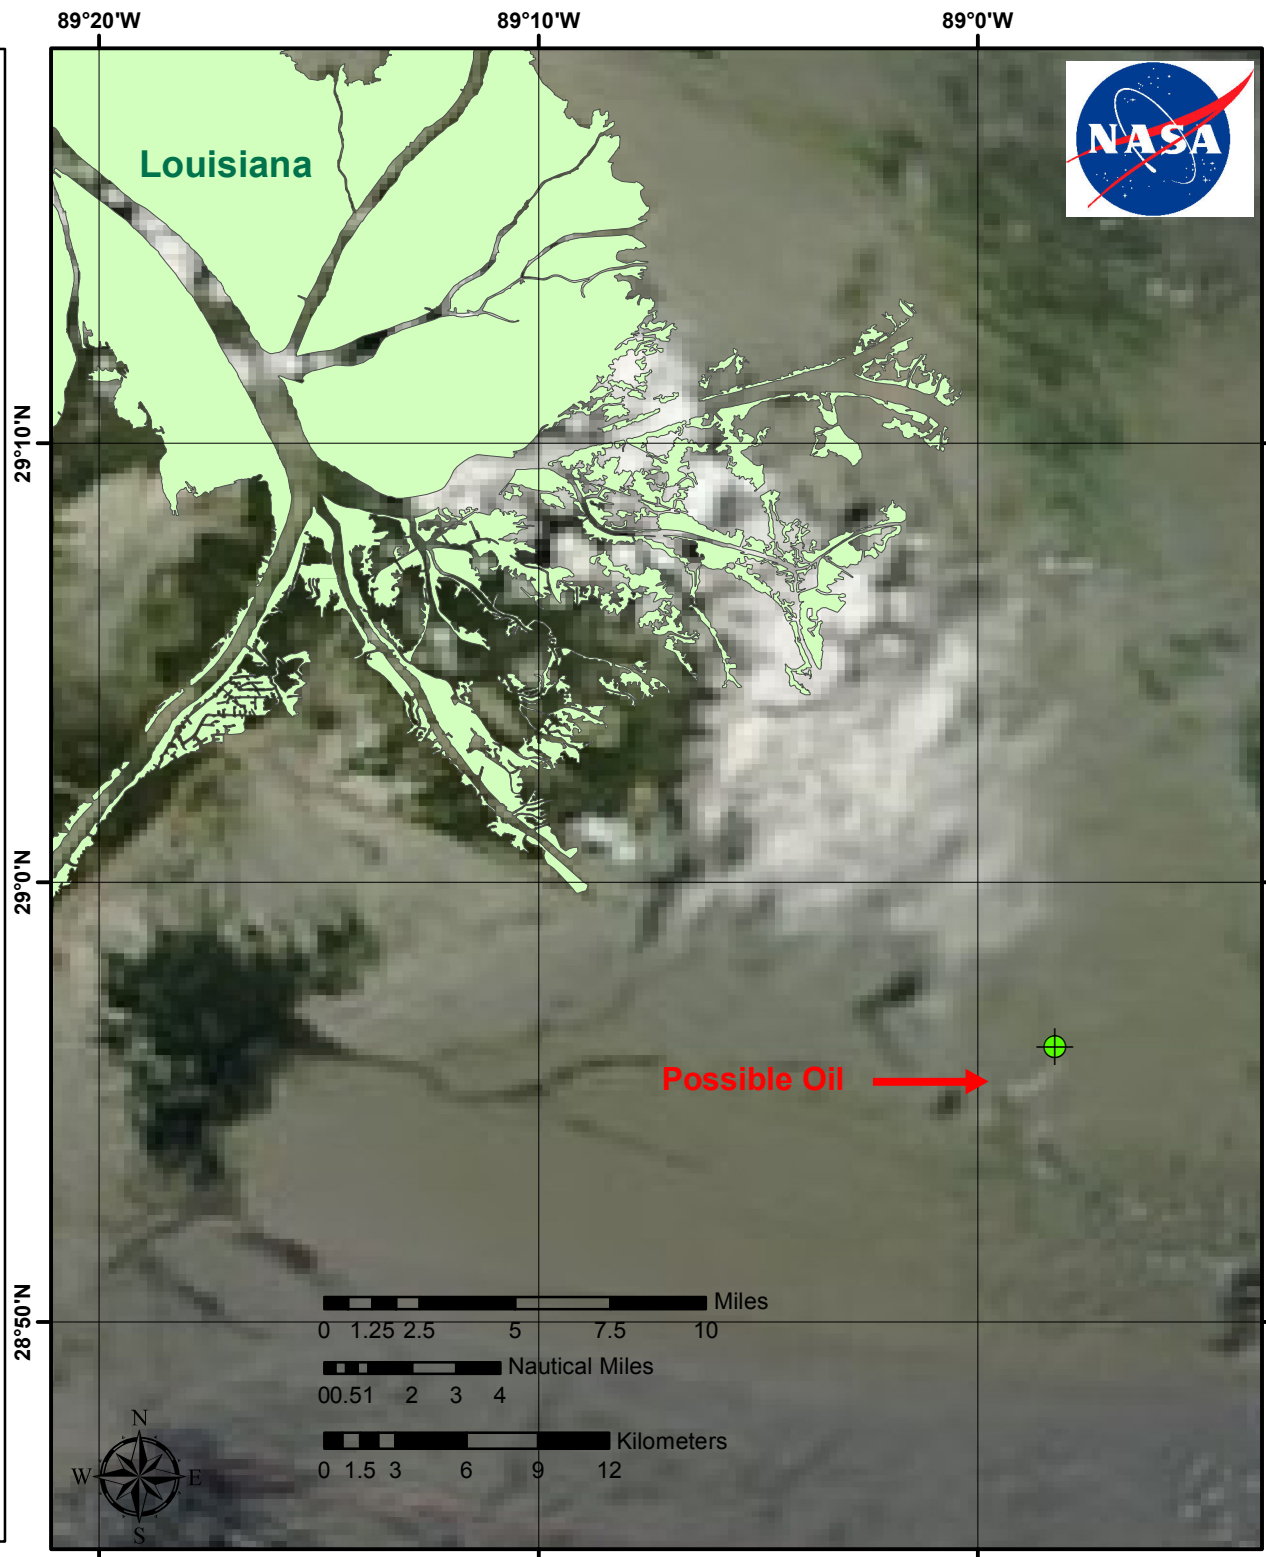
Destroyed Taylor Platform :
[28°56'9" N / 88°58'12" W]

Suspected oil sheen is observed emanating from the destroyed Taylor platform. The slick extends to the southwest for approximately 3km and is 1km in width. Wind data is not available in the immediate vicinity. Edges are not clearly defined due to low resolution but this feature can be differentiated from the nearby clouds and determined to be on the ocean surface by the lack of shadow.
