MARINE POLLUTION SURVEILLANCE REPORT

Analysis Provided by: The National Oceanic and
Atmospheric Administration/National Environmental
Satellite, Data and Information Service (NOAA/NESDIS)

REPORT DATE: AUGUST 08, 2012

Destroyed Taylor Platform :
[28°56'9" N / 88°58'12" W]

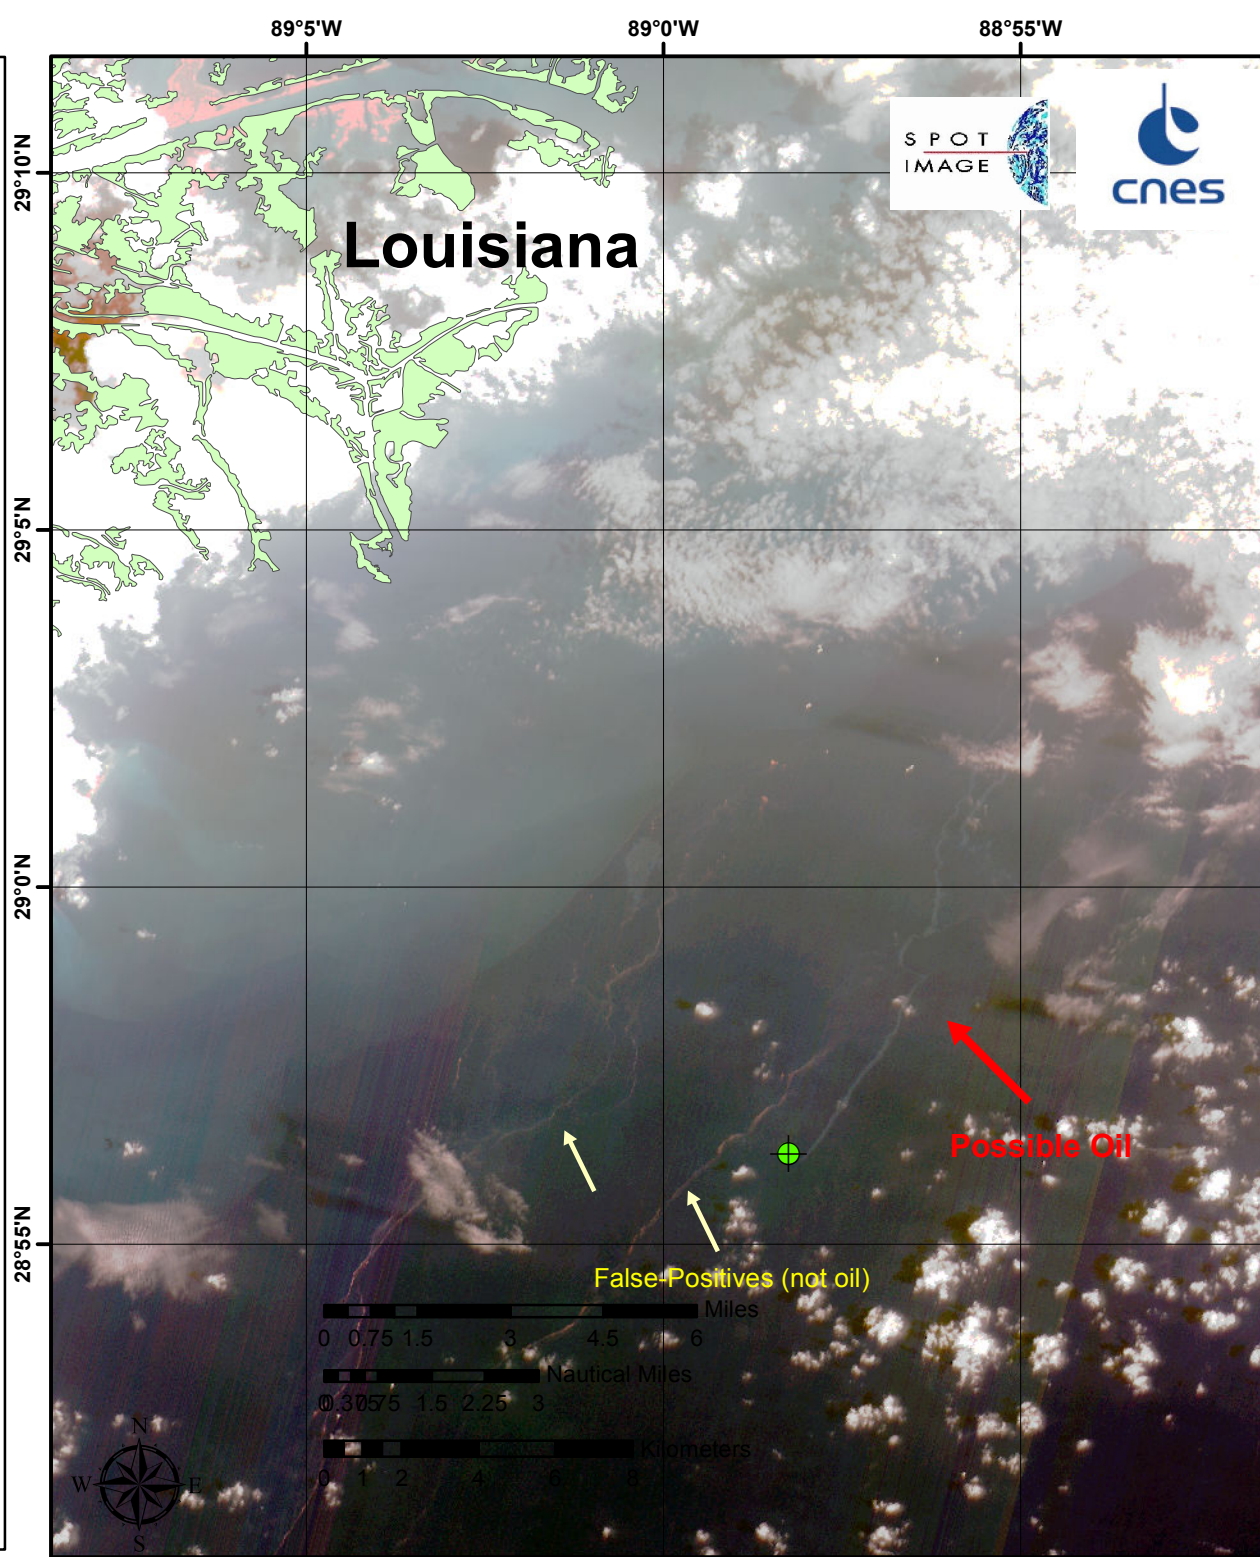
A possible oil slick from the destroyed Taylor platform
extended for 9.0 miles to the NNE. The slick was quite
narrow--up to 0.2 mile wide. Sky conditions were mostly
clear near the platform, but were partly to mostly cloudy
farther north, preventing full view of the most northern
extent. Winds were light on the most part and coming
out of the south.
