MARINE POLLUTION SURVEILLANCE REPORT

Analysis Provided by: The National Oceanic and
Atmospheric Administration/National Environmental
Satellite, Data and Information Service (NOAA/NESDIS)

Destroyed Taylor Platform :
[28°56'9" N / 88°58'12" W]

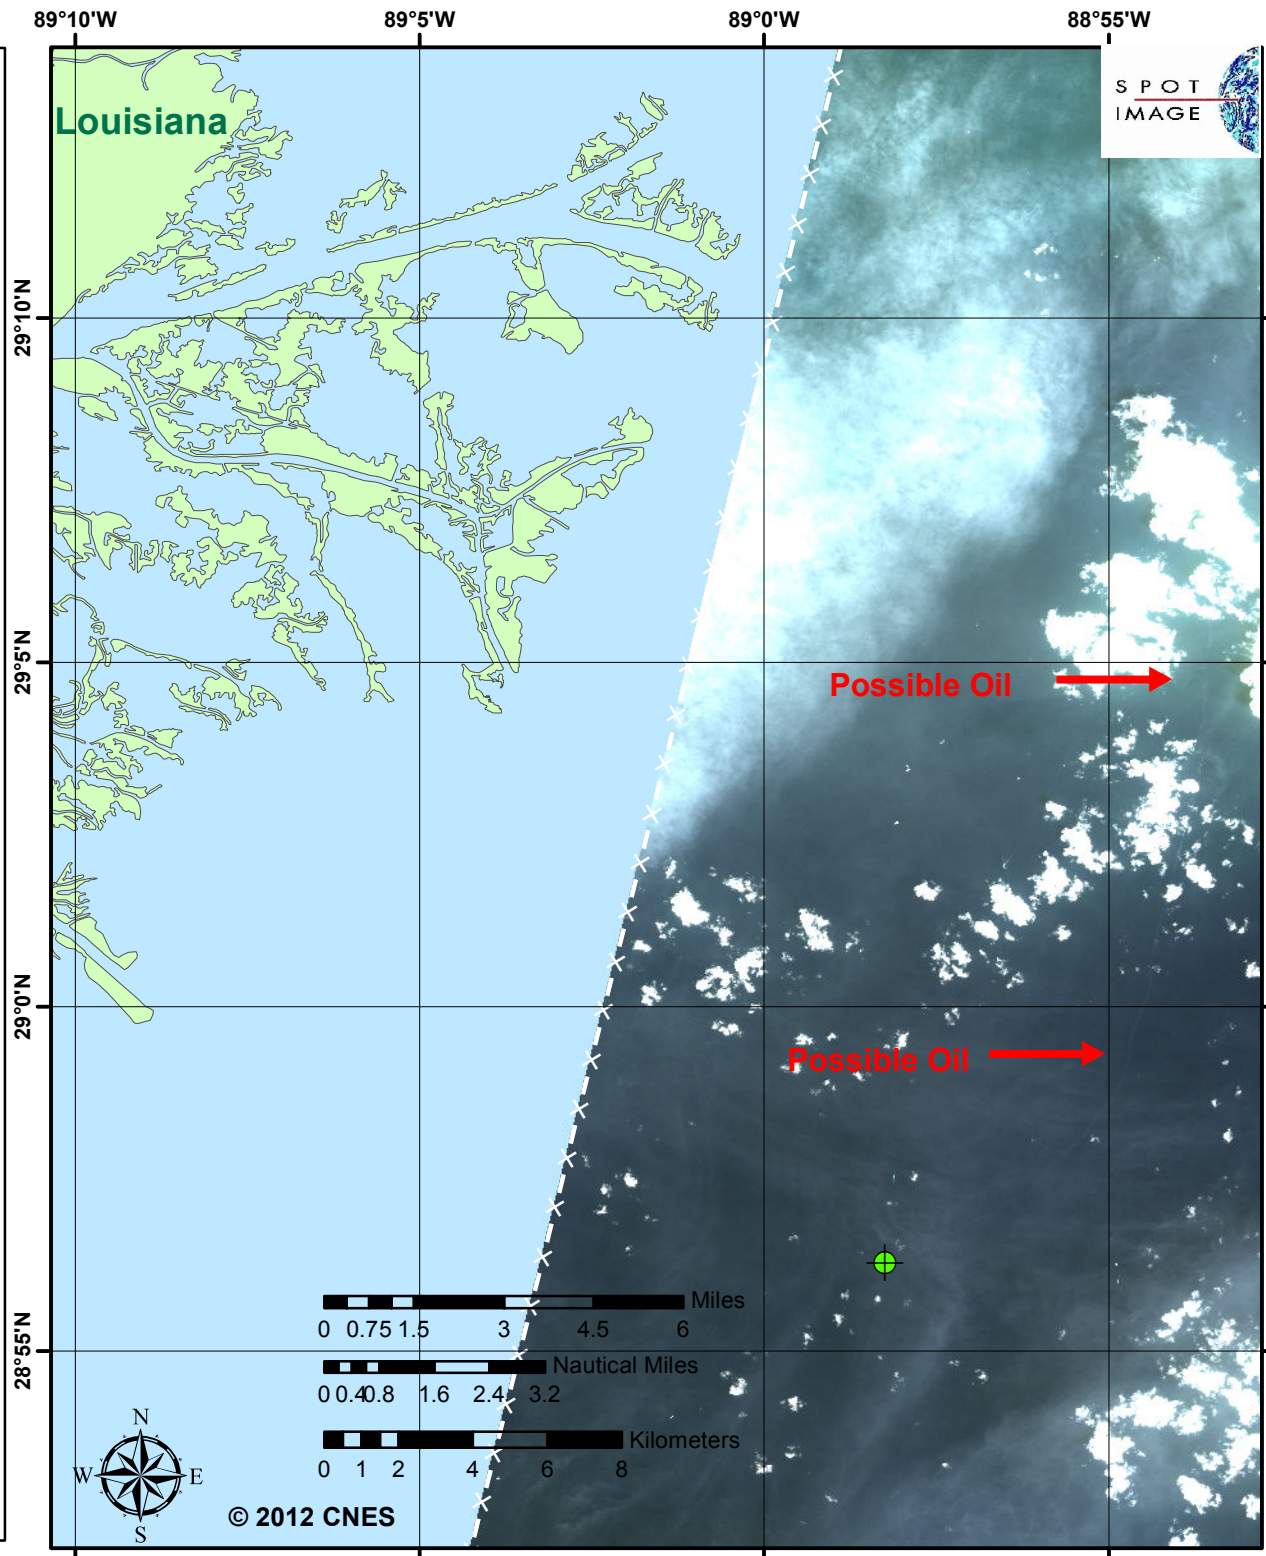
A possible oil slick from the destroyed Taylor platform extended for 12.5 miles to the north and east. The slick was quite narrow--up to 0.1 mile wide. Sky conditions were mostly clear near the platform, but were partly to mostly cloudy farther north, preventing a definitive assessment of the northern extent. In addition, there were breaks in the slick at the northern end along with biogenic material. Winds were light at about 5 knots and blowing from the south at the time of the image.
