# MARINE POLLUTION SURVEILLANCE REPORT

Analysis Provided by: The National Oceanic and  
Atmospheric Administration/National Environmental  
Satellite, Data and Information Service (NOAA/NESDIS)

REPORT DATE: MAY 25, 2012

Destroyed Taylor Platform :  
[ 28°56'9" N / 88°58'12" W ]

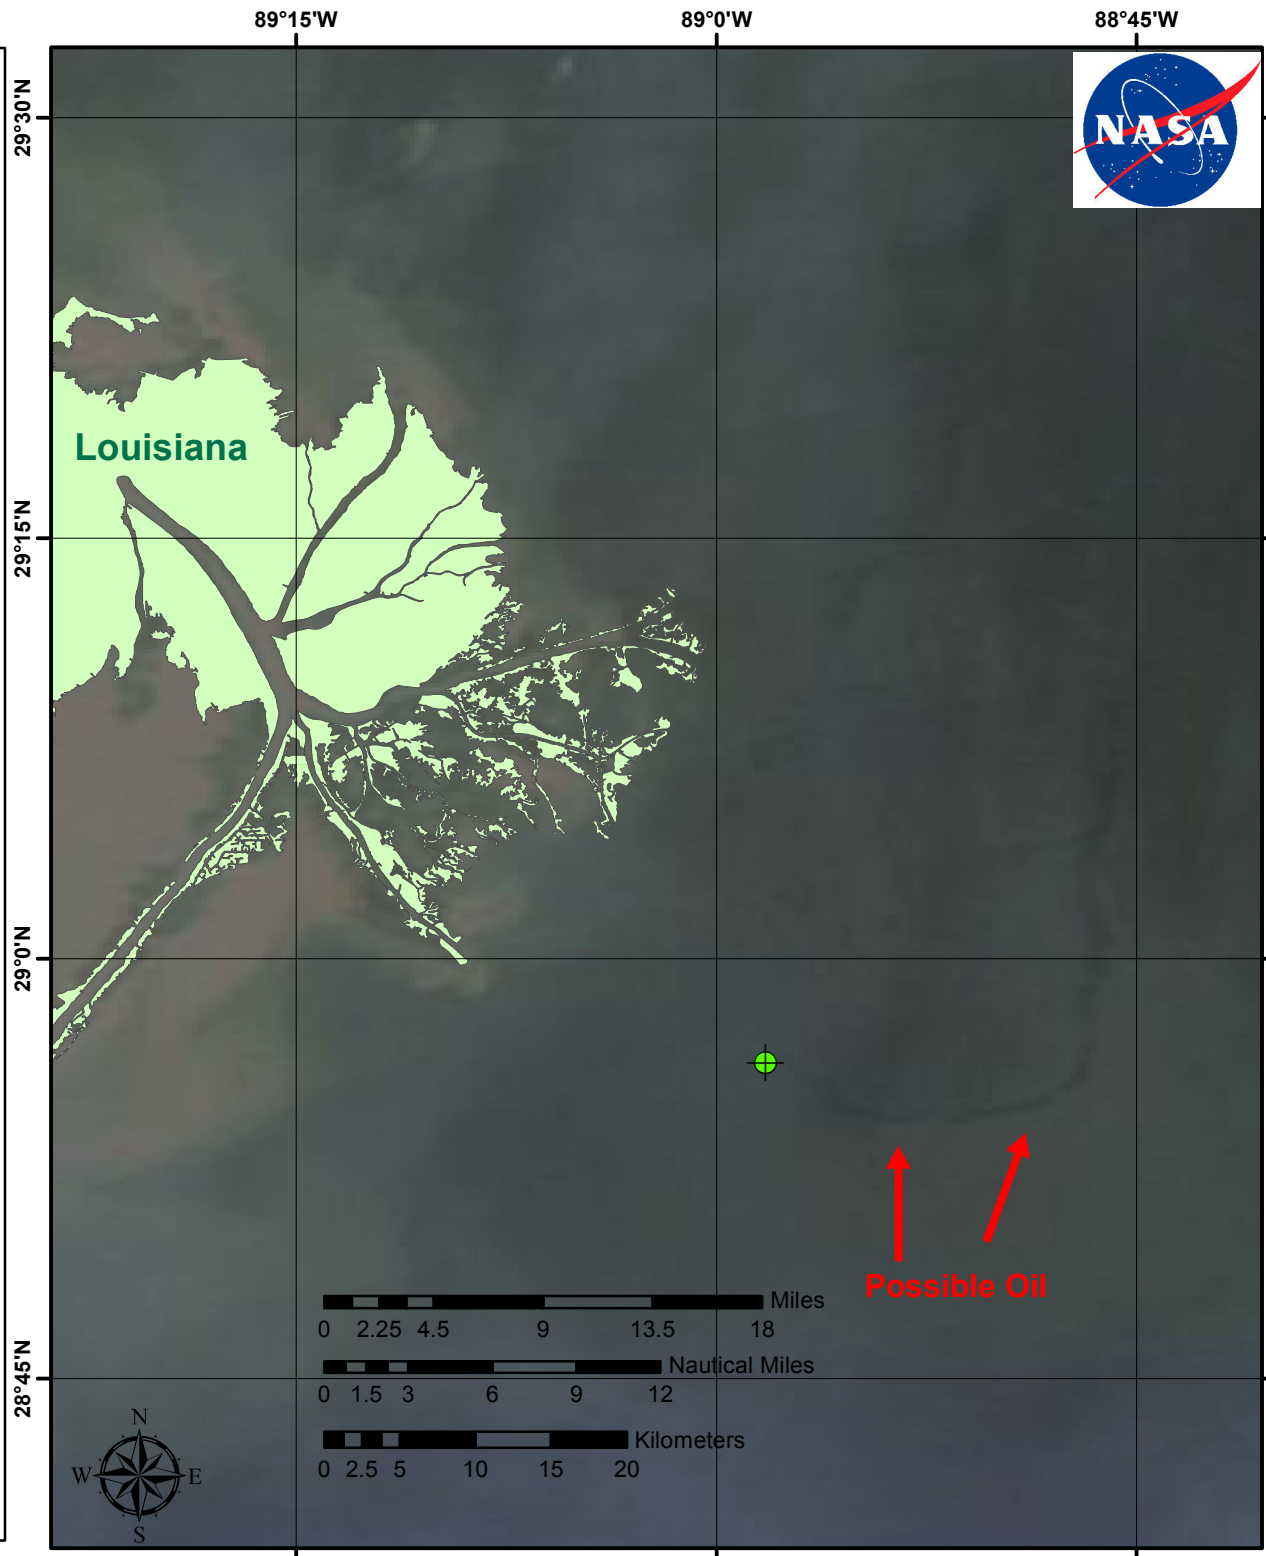
A discontinuous oil slick is seen emanating from very near the location of the destroyed Taylor platform which is believed to be the source point. The broken slick extends eastward approximately 10.5 miles before turning northward and extending another 15 miles in length.

Surface winds were out of the northeast at the time of the image with cloud-free skies over the Bird's Foot Delta, although moderately dense remnant smoke from fires was covering the north central Gulf of Mexico. NCOM model data suggested southwesterly surface currents just off the Birds Foot Delta with a convergence zone present very near the analyzed slick.
