MARINE POLLUTION SURVEILLANCE REPORT

Analysis Provided by: The National Oceanic and
Atmospheric Administration/National Environmental
Satellite, Data and Information Service (NOAA/NESDIS)

REPORT DATE: APRIL 20, 2012
REPORT TIME: 2000Z (1500 CDT)
ANALYST: GALLINA

Destroyed Taylor Platform :
[28°56'9" N / 88°58'12" W]

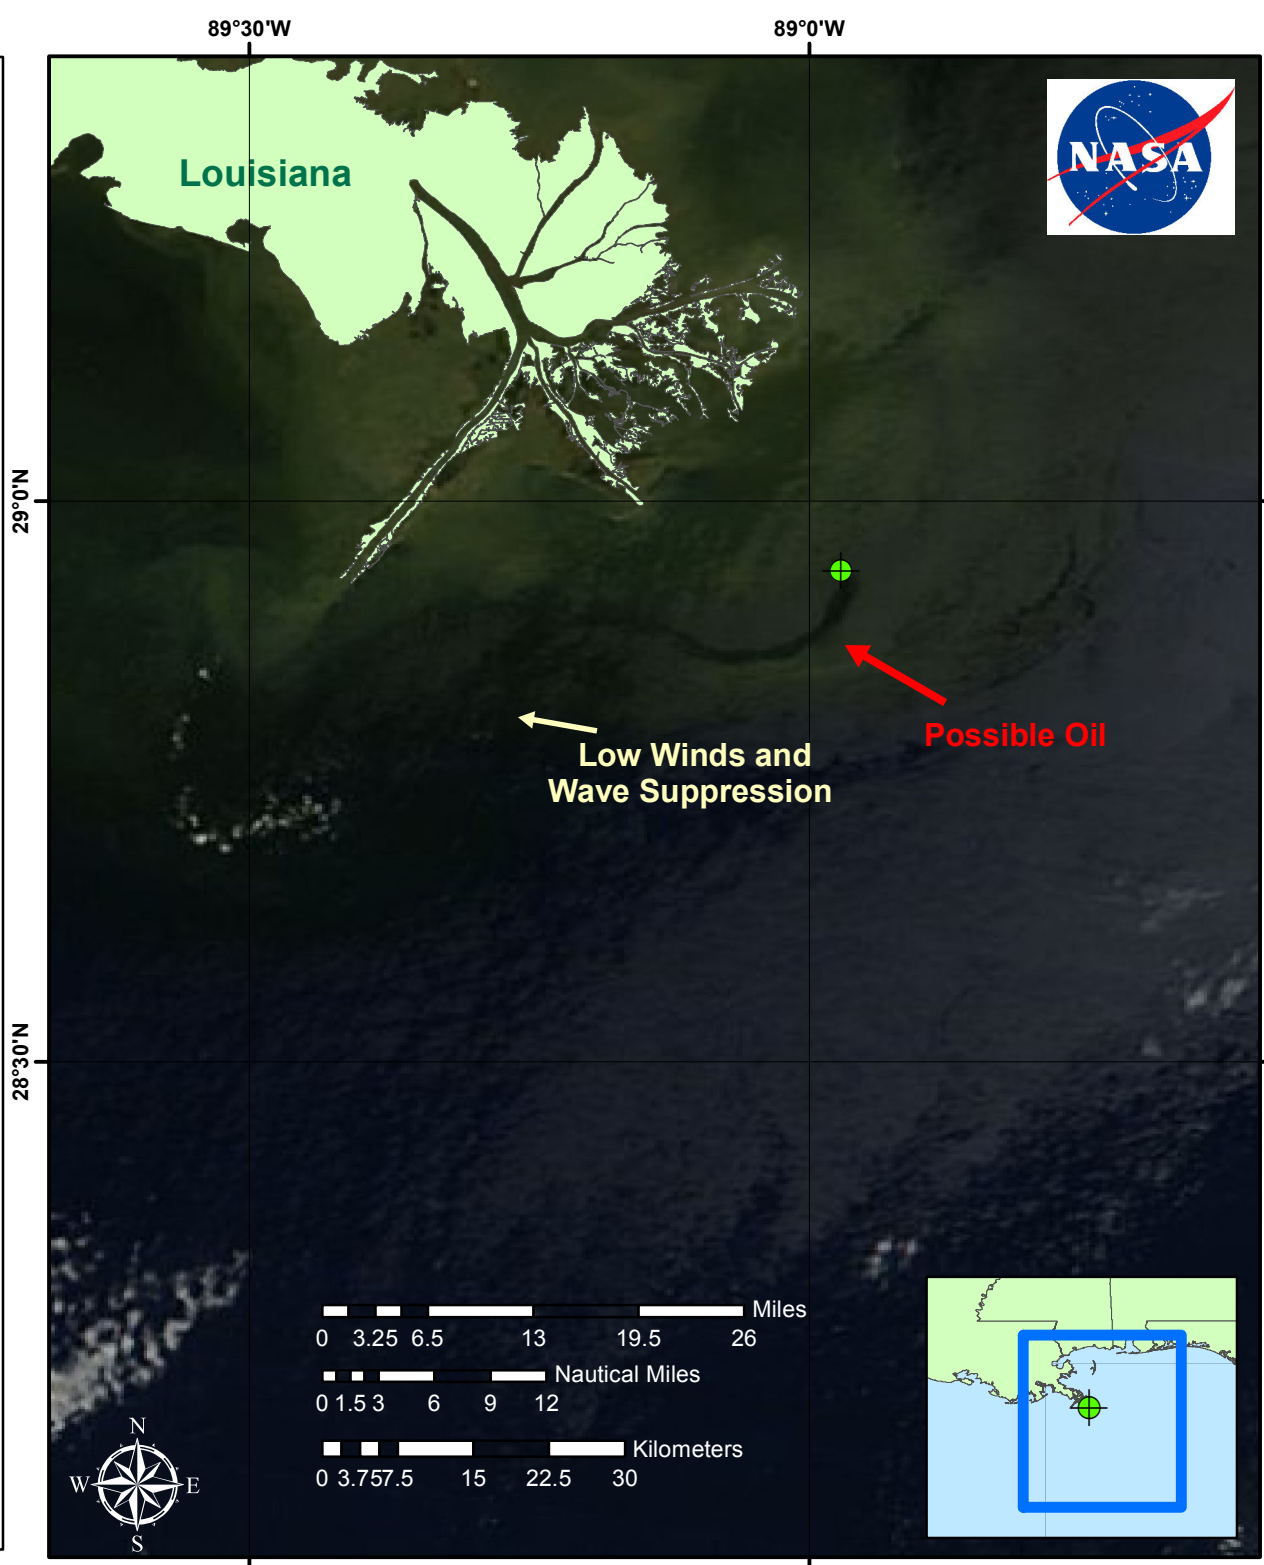
An anomaly is seen extending from the known leak site of Destroyed Taylor in a banana-shape arc toward the west-southwest extending about 18km with an average width about 2 km wide. It is possible the anomaly extends further west but darkness in imagery due likely to low winds and an area of suppressed waves making it difficult to impossible to fully determine anomaly edges. The western tip of the high confidence area is approx 35km south-southeast of the Bird's Foot Delta.
