MARINE POLLUTION SURVEILLANCE REPORT

Analysis Provided by: The National Oceanic and
Atmospheric Administration/National Environmental
Satellite, Data and Information Service (NOAA/NESDIS)

REPORT DATE: SEPTEMBER 10, 2011

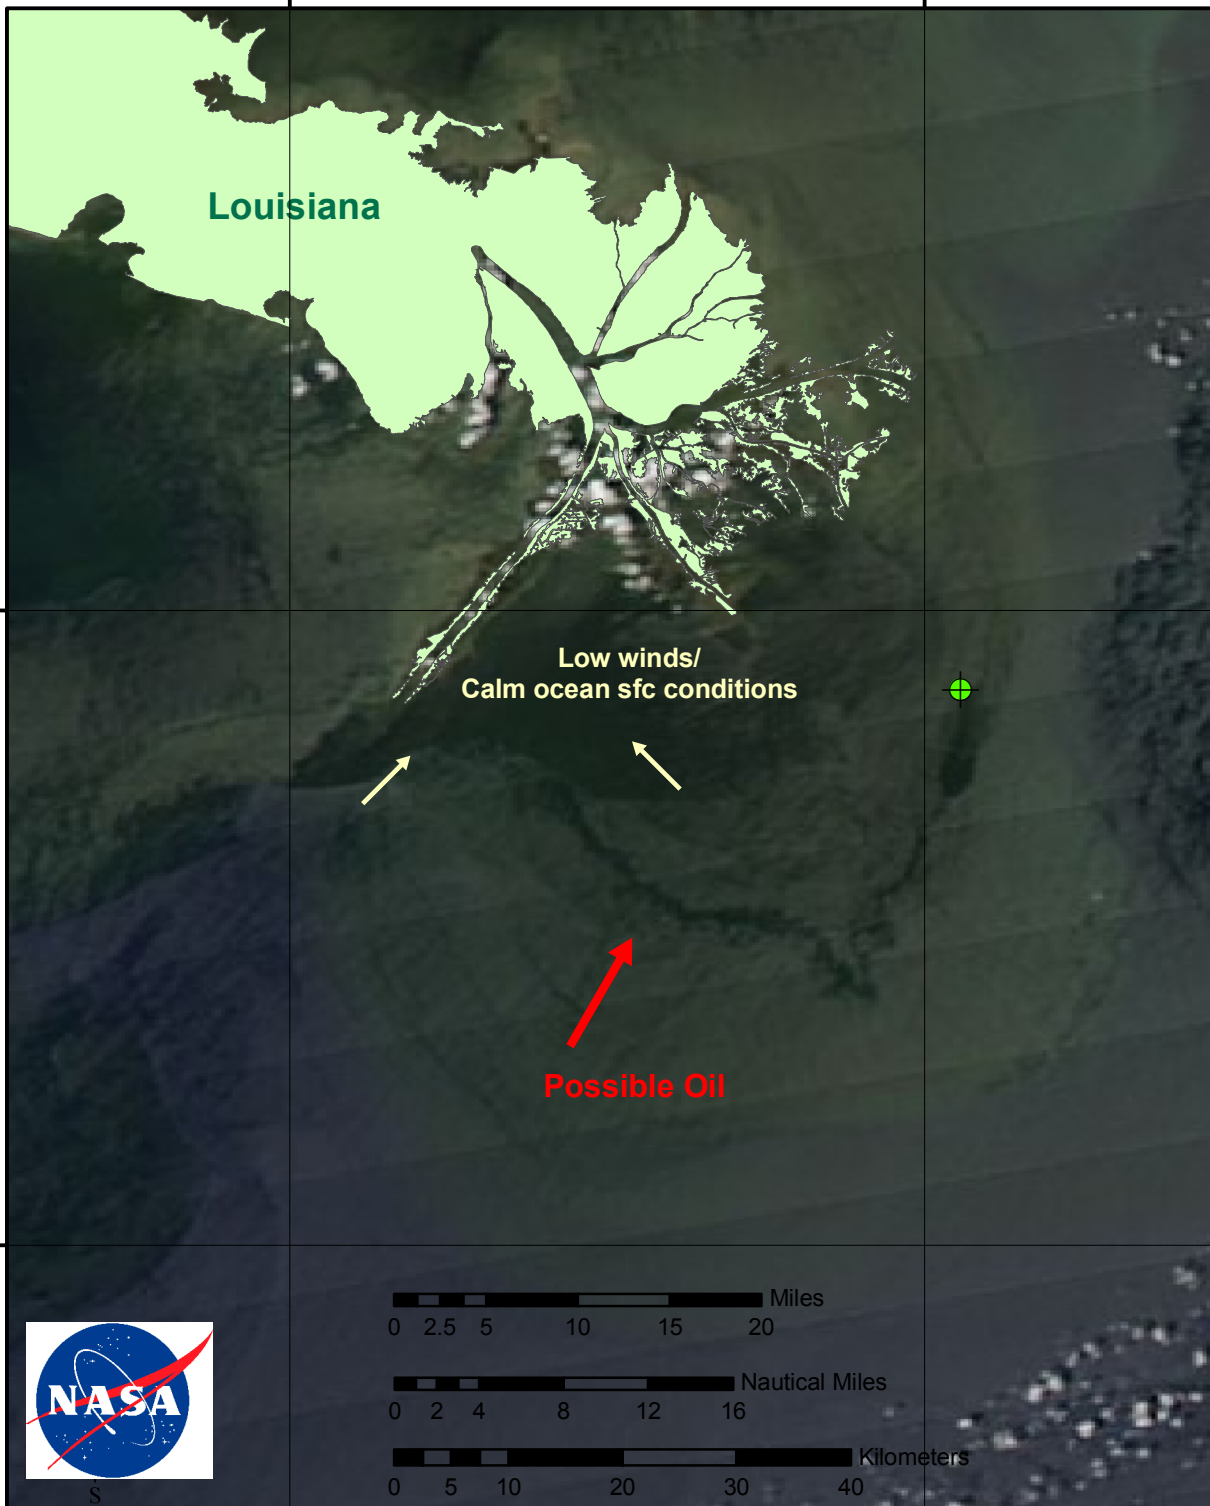
Destroyed Taylor Platform :
[28°56'9" N / 88°58'12" W]

REMARKS: Suspect oil connected to Destroyed Taylor platform has very similar features to yesterday's suspect area, but continues to thin out. However, surface ocean currents have allowed the oldest portion of the slick to curve back north and west toward the Southwest Pass of the Mississippi River and East Bay and is about 9 miles Southeast of the Southwest Pass.
