# MARINE POLLUTION SURVEILLANCE REPORT

REPORT DATE: JULY 17, 2012  
REPORT TIME: 2350Z (1850 CDT)  
ANALYST: BELGE

DATA SOURCE: AQUA MODIS  
MODE: Multispectral  
RESOLUTION: 250 meter  
IMAGE DATE/TIME: 7/17/2012 1905Z (1405 CDT)

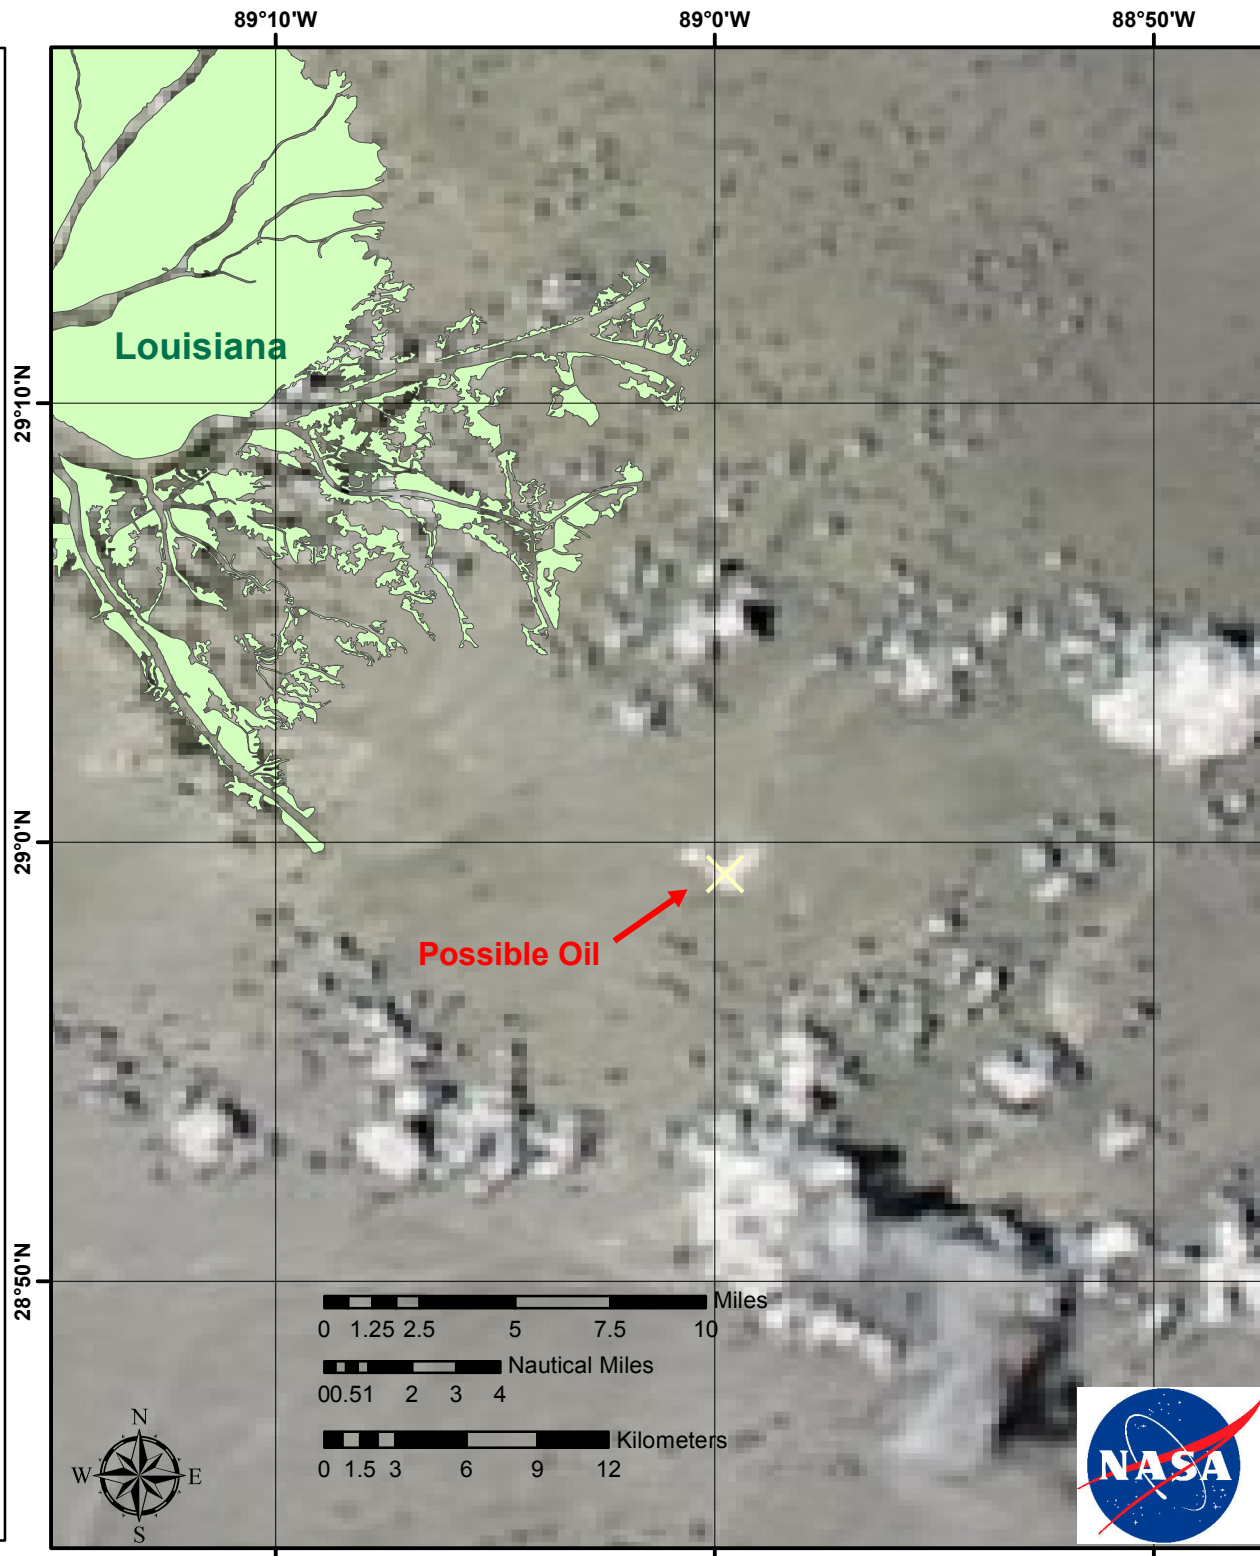
Center Point of Oil Slick:  
[ 28°59'17" N / 88°59'43"W ]

A possible oil slick can be seen about 11 miles to the east of East Bay in the Bird's Foot Delta region of Louisiana. Winds at this time were around 5 knots or less from the south/southeast with partly cloudy conditions throughout the northern Gulf of Mexico with relatively clear skies right over the oil site. There are oil rigs in the vicinity, including the Destroyed Taylor Platform which is located to the south/southeast about 3-4 miles, but at this time, no specific point source can be identified.
